YEAR
1991

MODEL
LEGEND LS

BULLETIN NO.
91-028

Lower Dashboard Cover/Courtesy Light Controller Replacement

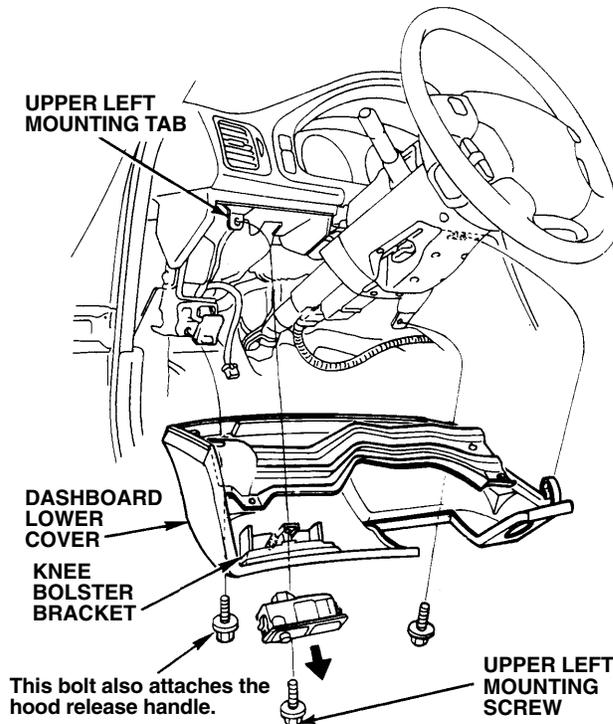
The courtesy light controller cannot be removed from the driver's-side lower dashboard cover without damaging the cover or controller.

1. Remove the lower dashboard cover's two lower mounting screws.

2. Carefully pry the lower edge of the cover away from the dashboard, then forcibly remove the cover by breaking the knee bolster bracket.

3. Lower the cover and disconnect the courtesy light controller connector. Push the controller from the rear while releasing its retaining clips with a small flat tip screwdriver.
4. Remove the broken knee bolster bracket and the courtesy light controller, then install a new knee bolster bracket (see PARTS INFORMATION).
