**ACURA ServiceNews**

BSN 16184 (9310)

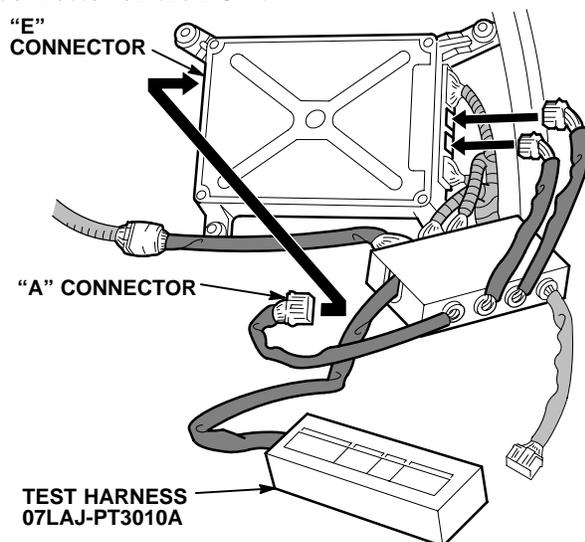
Most of the electrical troubleshooting flowcharts in the A/T section of a '91-94 Legend S/M have you connect the test harness (T/N 07LAJ-PT3010A) to the PCM and take readings at the "A" terminals in the test harness. But remember, when you use this test harness for a Legend A/T problem, you must connect the "A" connector on the test harness to the "E" connector on the PCM (the one on the left side of the PCM). When connected in this fashion, the "A" section of the test harness corresponds to the "E" connector on the PCM.

Because this same test harness is used for PGM-FI problems, some people forget and automatically connect the "A" test harness connector to the "A" connector on the PCM. However, this combination will cost you time and needless parts replacement if you're trying to find a trans problem.

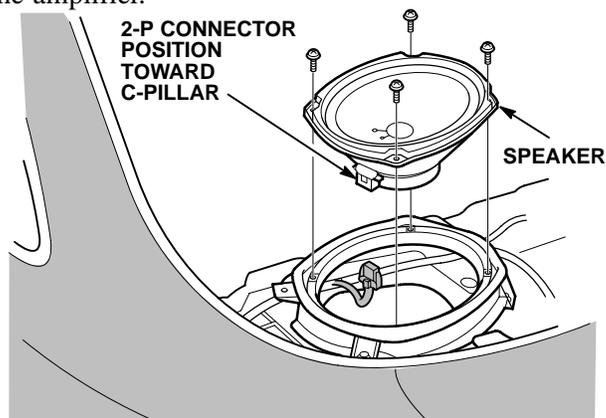
A rear speaker on a '91-94 Legend Coupe should be installed with the connector-end facing toward the C-pillar. If you mistakenly turn the speaker 180 degrees and install it with the connector-end facing the center of the car, the speaker terminals may touch the rear shelf support and short to ground. This is an expensive mistake on an LS model because it ruins the amplifier.

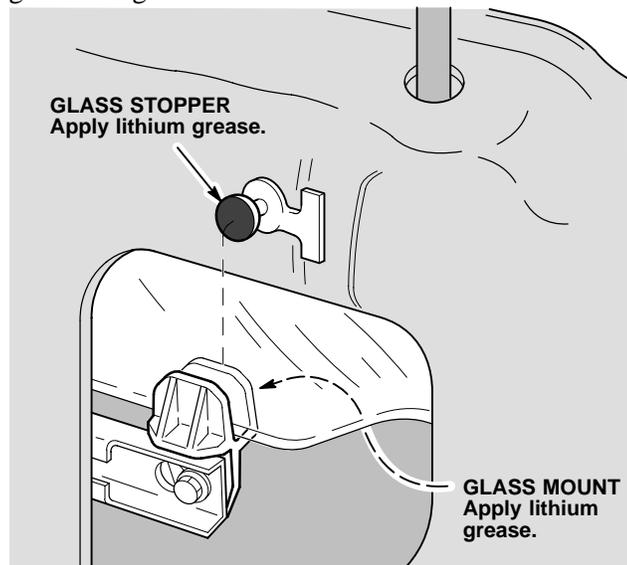
A creaking noise from the door glass on a '91-93 Legend Coupe, after it's fully closed and you've released the power window switch, is usually caused by one of two things.

The other cause is dry glass stopper areas on the glass and the door. These also need to be lubricated with white lithium grease. To do so, remove the door glass as described in the S/M. Then, apply the grease to the rubber pads on the two glass stoppers (on the door) and the outer sides of the two white plastic glass-to-regulator mounts.
