## What to Expect on the New Integra

## 93 Legend Idle Speed Adjustment

**ACURA** ServiceNews

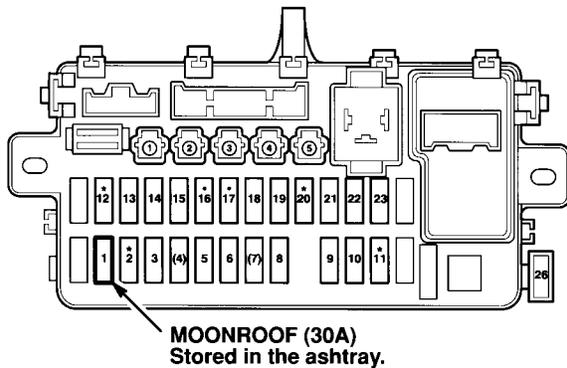
### UNDER-DASH FUSE/RELAY BOX

**Fuse installation at PDI:** To get all systems functioning, remove the following fuses from their storage areas and install them in the proper positions.

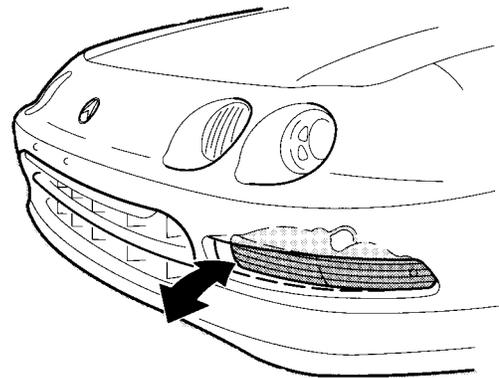
**Spring-loaded front turn signals:** The combined front turn signal and side marker light assemblies are spring-loaded to survive minor impacts. You can push the lights in about an inch, and they’ll pop back to their original position.

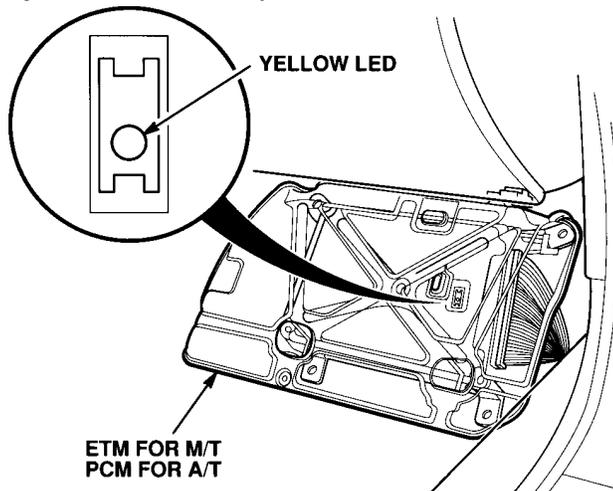
The idle speed adjustment procedure in the 1993 Legend S/M uses the yellow LED on ECM/PCM to check the idle speed. However, the idle speed adjustment procedure in the October 1991 issue of S/N is less time-consuming. (In a nutshell, adjust the idle speed to 500 rpm with the EACV disconnected and the headlights, rear defogger, and blower fan on.)

After setting the idle speed, reconnect the EACV, and clear the ECM/PCM. Jump the service check connector, and start the engine. The yellow LED should be off. If the LED is blinking, turn the adjusting screw 1/4 turn clockwise; if it's on, turn the adjusting screw 1/4 turn counterclockwise. Wait 30 seconds, then check the LED to determine if further adjustment is necessary.
