Low-Power, No Full Throttle Upshifts

ACURA ServiceNews

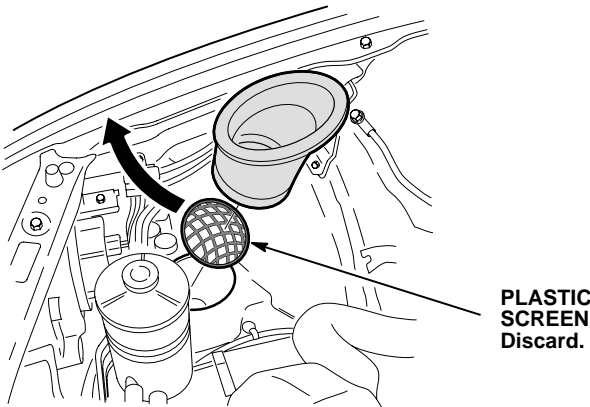
A '91-94 Legend that accelerates poorly, is generally down on power, and (if A/T-equipped) won't upshift at full throttle, may have a restriction in the fresh-air side of the intake air tract.

Slip the intake air duct off of the throttle body, and test drive the car again. If the performance and shifting are back to normal, remove the air cleaner housing and the rubber duct that connects it to the intake air pipe. The duct contains a plastic screen that's designed to keep stray hardware from falling *down* into the resonator. However, if debris gets sucked *up* into the fresh air intake, the screen will stop it, causing a restriction.

Use a shop vacuum to clean the resonator cavity thoroughly. (The debris may only be held against the screen when the engine is inhaling a lot of air and fall down out of sight when there is no air flow.) When you reassemble the air cleaner, don't reinstall the screen; discard it.

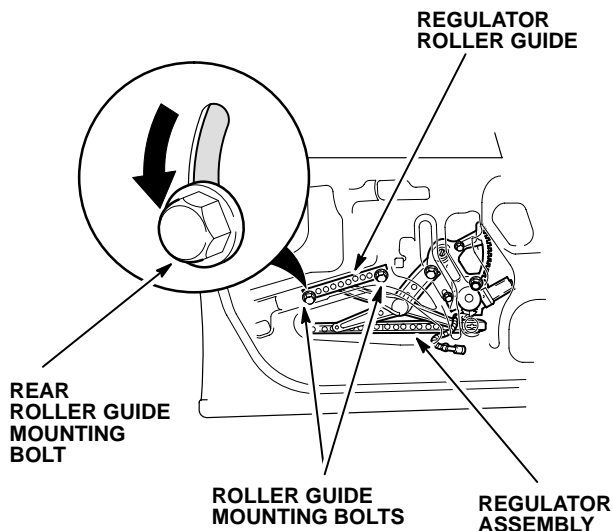
If you have wind noise from the front door glass of a '91-93 Legend Sedan, the first thing you should do is adjust the glass as described in S/B 91-012, "Wind Noise From Door Glass." If you still have an audible wind leak at the run channel (detectable with a stethoscope) after adjusting the glass, use the following procedure to replace the run channel.

1. Remove the door panel and the inner and outer moldings.
2. Remove the door glass and the old run channel.
3. Inspect the new run channel for any pinholes or other flaws at the top of the door mirror area. Seal any holes or flaws with adhesive.
4. Lubricate the run channel with silicone spray, and install it carefully. Make sure it engages the door channel fully.
5. Reinstall the door glass and inner and outer moldings.
6. Move the rear roller guide bolt down to the bottom of its adjusting slot.

7. Temporarily reinstall the door panel (leave the screws out).
8. Test drive the car, and listen for the wind noise with your stethoscope. If necessary, readjust the door glass so that it engages the run channel properly (see steps 9 and 10 of S/B 91-012).
