**ACURA ServiceNews**

BSN 16110 (9309)

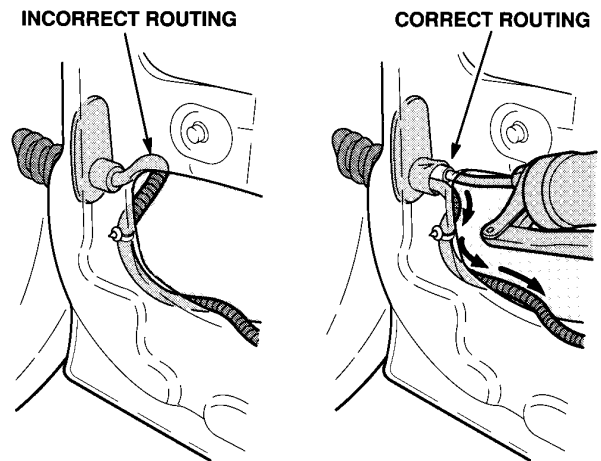
**Legend Rear Power Window Won't Work**

Corrosion, caused by moisture, in the rear door harness connector may cause a rear door window on a 1991-93 Legend to quit working.

To prevent the problem from recurring, remove the rear door panel. Look at the corrugated rear door harness protector where it goes into the rubber boot at the front of the door. You'll probably find that it enters the boot at a downward angle, which allows water to run down the wires to the connector. If so, release the harness from the first clip that holds it to the door. Pull the harness down (about 2") so that it enters the boot at an upward angle, then secure it with the clip. Pack the boot with dielectric grease where the corrugated protector enters, then reinstall the door panel.

Remove the center pillar lower trim, the seat belt retractor, and the plastic retractor cover from the appropriate side of the car, and inspect the rear door harness connector (C405 on the right side, C266 on the left side). If the connector is corroded, you've found the culprit. (Otherwise, keep on troubleshooting.) Clean the connector, and pack it with dielectric grease.

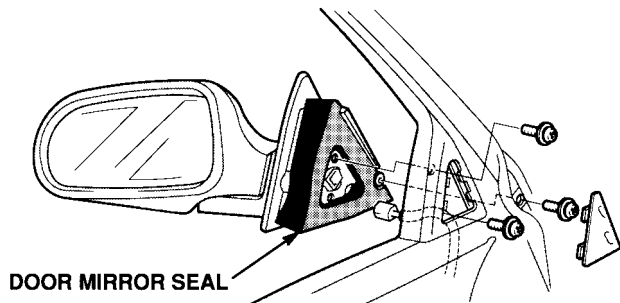
## Legend Sedan Door Mirror Seals

The urethane seals for the door mirrors on 1991-93 Legend Sedans are now available separately. (Previously, you had to replace the whole mirror if the seal was deformed or torn.) The part numbers are as follows:

Door Mirror Seal: . Left: P/N 76285-SP0-A01  
Right: P/N 76235-SP0-A01

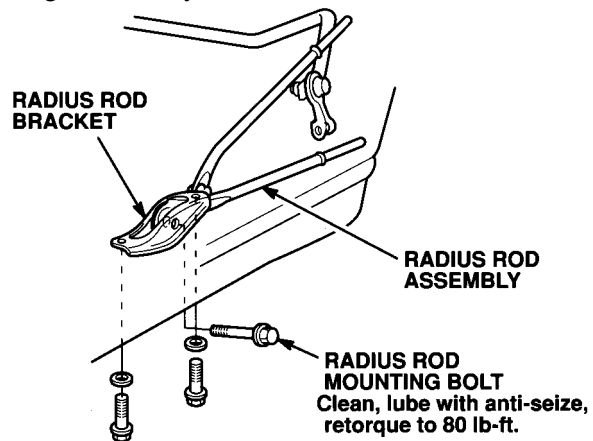
## Legend Rear Suspension “Cracks”

A loud “cracking” noise from the rear suspension of a 1991-93 Legend when driving over sharp-edged bumps or holes may occur if the radius rod bushing isn’t clamped tightly in its bracket. To increase the clamping force of the radius rod mounting bolt, first remove the two radius rod bracket mounting bolts, then remove the radius rod mounting bolt. Clean the mounting bolt threads thoroughly, lubricate them with anti-seize, then torque the mounting bolt to 80 lb-ft during reassembly.
