Extension Shaft Secondary Cover

ACURA ServiceNews

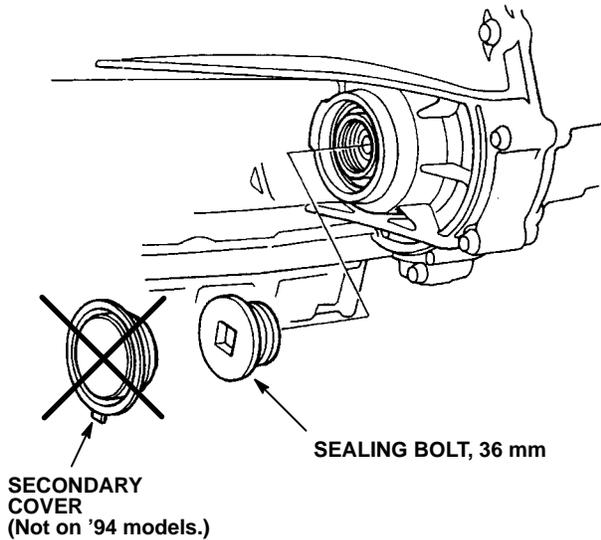
The extension shaft secondary cover (the one over the 36 mm sealing plug at the end of the extension shaft) has been eliminated from '94 Legends. Both the S/M and the current parts microfiche still show this part for the '94 models, but this will be corrected in future revisions.

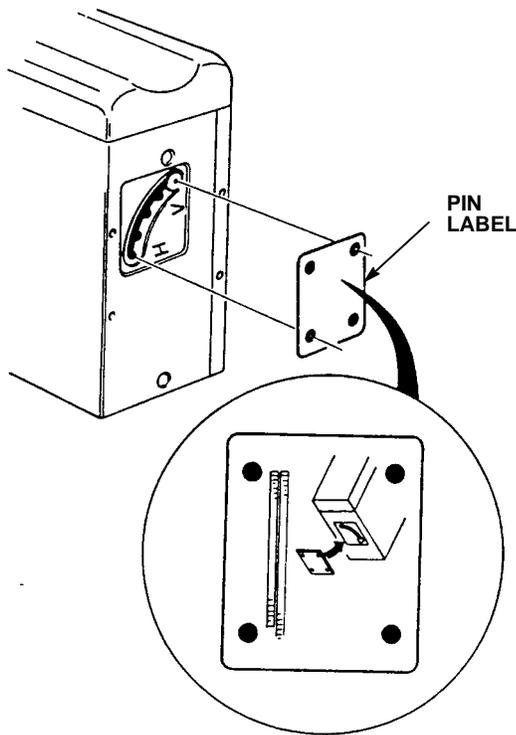
'94 CD Changer Installation

The '94 model CD changer, P/N 08A06-142-420, can be mounted either horizontally or vertically, depending on the application. To accommodate these two mounting positions, the springs on the CD changer can be adjusted accordingly (see the appropriate installation instructions). After the springs are adjusted, you *must* apply the "pin labels" over the spring pins. These labels prevent the spring pins from dislodging and moving when the car is driven over bumps. (If the springs aren't positioned properly, the CDs will skip excessively.)
