Extension Shaft Secondary Cover

ACURA ServiceNews

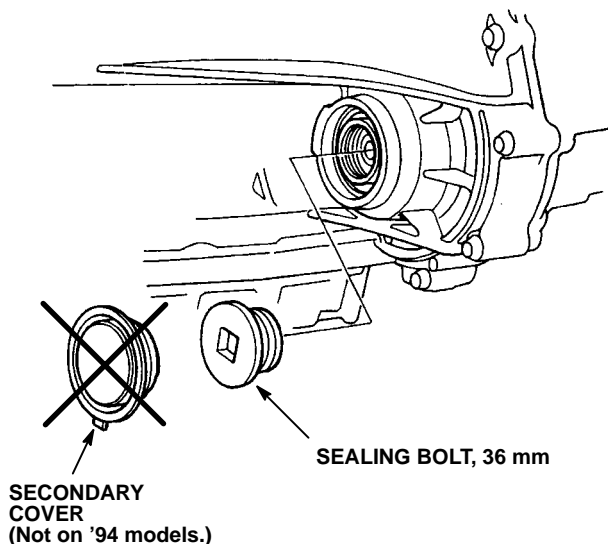
The extension shaft secondary cover (the one over the 36 mm sealing plug at the end of the extension shaft) has been eliminated from '94 Legends. Both the S/M and the current parts microfiche still show this part for the '94 models, but this will be corrected in future revisions.

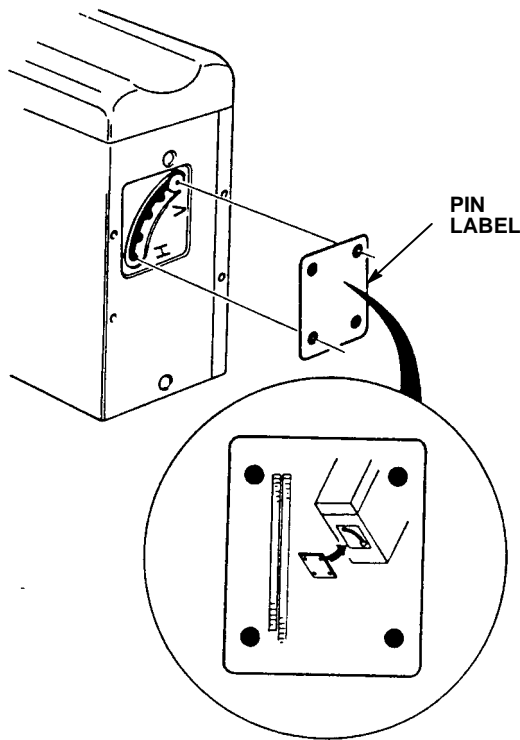
The '94 model CD changer, P/N 08A06-142-420, can be mounted either horizontally or vertically, depending on the application. To accommodate these two mounting positions, the springs on the CD changer can be adjusted accordingly (see the appropriate installation instructions). After the springs are adjusted, you *must* apply the "pin labels" over the spring pins. These labels prevent the spring pins from dislodging and moving when the car is driven over bumps. (If the springs aren't positioned properly, the CDs will skip excessively.)
