YEAR  
1991

MODEL  
LEGEND

BULLETIN NO.  
91-047

## Car Drifts to One Side

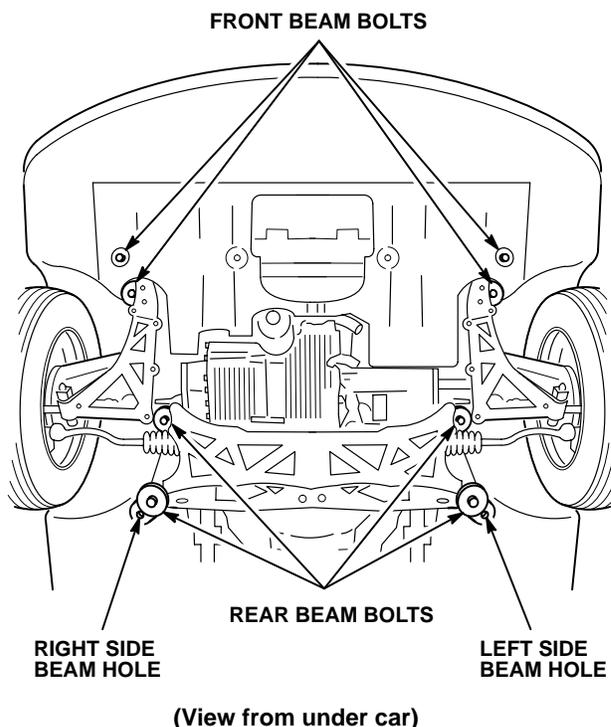
A side-to-side difference in front camber greater than 0.4 degree (24 minutes) can cause the car to drift towards the side with more positive camber.

1. Raise the car on a lift with the wheels off the ground.
2. Loosen the 4 front beam bolts and the 4 rear beam bolts; do not remove them.

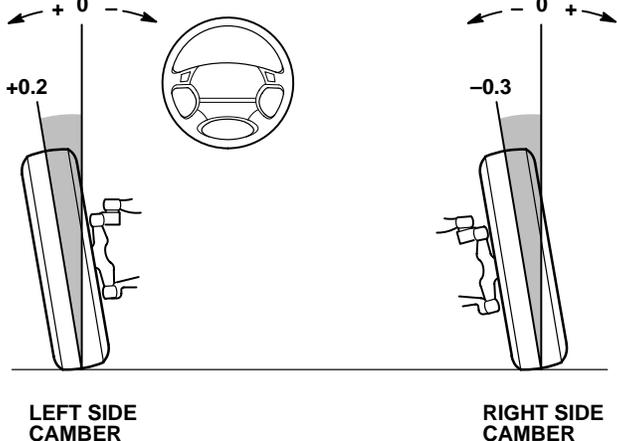
EXAMPLE: If the left side measures at +0.2 degree and the right side measures at -0.3, the side-to-side difference would be 0.5 degree.

- Refer to section 18 of the service manual and remove the left front and left rear damper springs. Replace the springs with the parts listed in PARTS INFORMATION.
