YEAR
1991

MODEL
LEGEND

BULLETIN NO.
91-047

Car Drifts to One Side

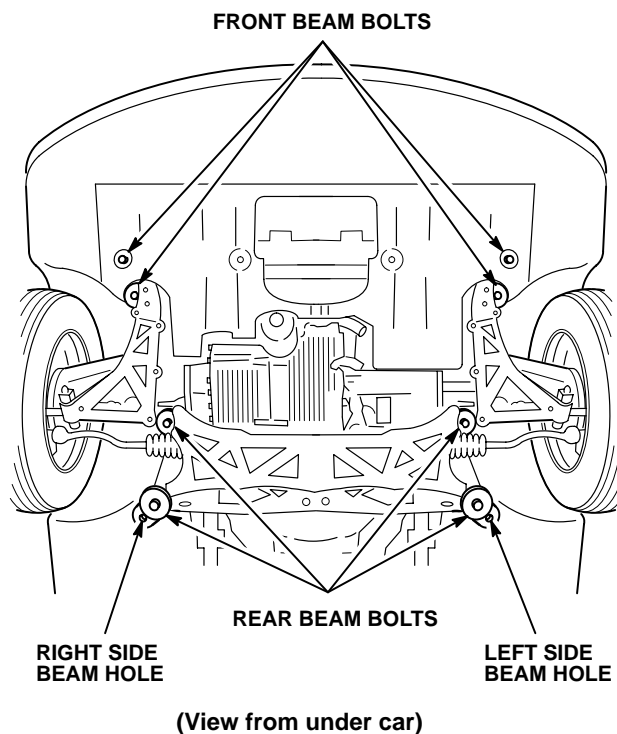
A side-to-side difference in front camber greater than 0.4 degree (24 minutes) can cause the car to drift towards the side with more positive camber.

1. Raise the car on a lift with the wheels off the ground.
2. Loosen the 4 front beam bolts and the 4 rear beam bolts; do not remove them.

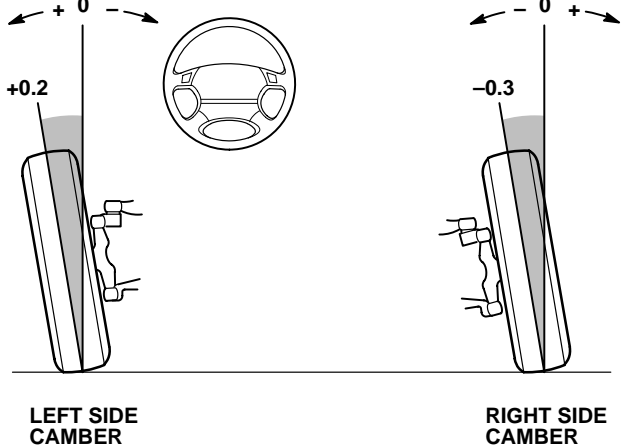
EXAMPLE: If the left side measures at +0.2 degree and the right side measures at -0.3, the side-to-side difference would be 0.5 degree.

8. Refer to section 18 of the service manual and remove the left front and left rear damper springs. Replace the springs with the parts listed in PARTS INFORMATION.
