## Legend Ashtray Won't Stay In

**ACURA** ServiceNews

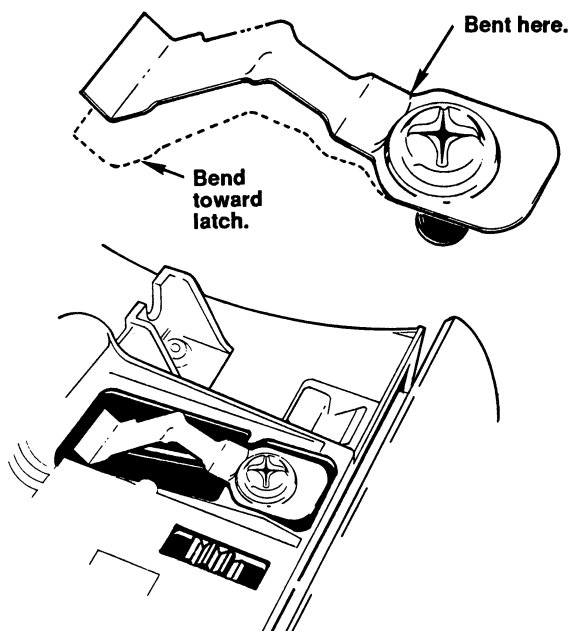
Pulling a '91 Legend ashtray out, instead of pushing it in and letting it come out by itself, deforms the latch spring. Then the ashtray won't stay in. Luckily, the spring is easily repaired; you don't have to replace the ashtray.

Remove the center console panel as shown on page 20-58 of the S/M. Remove the four screws that secure the ashtray to the panel, then turn the ashtray over. Remove the Phillips screw and the latch spring. Straighten the spring (it usually bends near the screw) so that it applies more pressure to the latch. Reinstall the spring, hold the ashtray upright and level, and check the operation. If the ashtray stays in, the spring tension is OK.

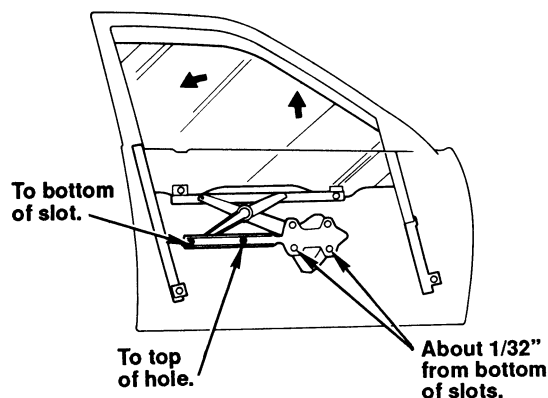
If you're having trouble adjusting the front door glass on a '91 Legend Sedan so that it seals properly at the rear of the door, try the following procedure:

1. Remove the door panel as described on page 20-3 of the S/M.
2. Loosen the two roller guide bolts and the four regulator/motor bolts.
3. Lower the glass a few millimeters. Lift the front of the glass up and push the rear of the glass back into the run channel. Hold the glass in this position.
4. First, tighten the rear roller guide bolt (it should be at the bottom of its adjustment slot). Next, tighten the front roller guide bolt (it should be at the top of its hole). Finally, tighten the four regulator/motor bolts (they should be about 1/32" from the bottom of their adjustment slots).

NOTE: If the door glass doesn't seal in the "A" pillar or mirror area, adjust the roller guide in the opposite direction.
