Legend Ashtray Won't Stay In

ACURA ServiceNews

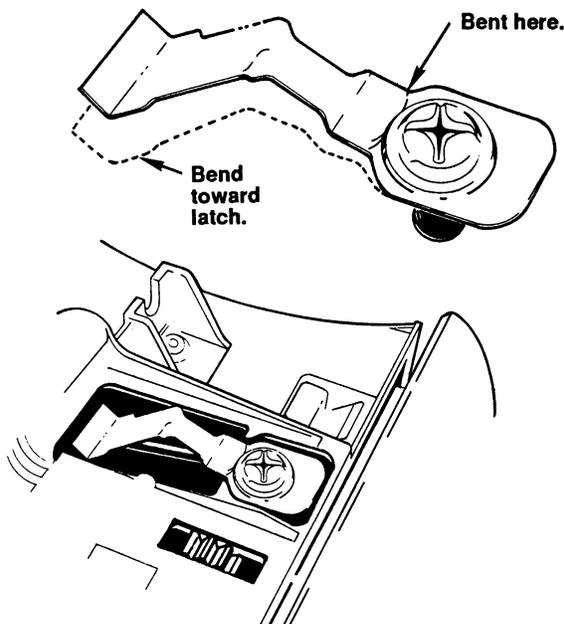
Pulling a '91 Legend ashtray out, instead of pushing it in and letting it come out by itself, deforms the latch spring. Then the ashtray won't stay in. Luckily, the spring is easily repaired; you don't have to replace the ashtray.

Remove the center console panel as shown on page 20-58 of the S/M. Remove the four screws that secure the ashtray to the panel, then turn the ashtray over. Remove the Phillips screw and the latch spring. Straighten the spring (it usually bends near the screw) so that it applies more pressure to the latch. Reinstall the spring, hold the ashtray upright and level, and check the operation. If the ashtray stays in, the spring tension is OK.

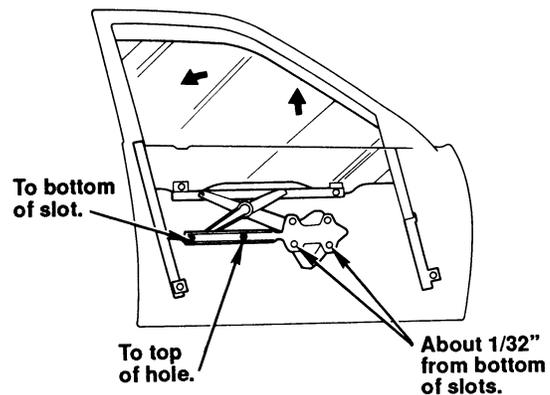
If you're having trouble adjusting the front door glass on a '91 Legend Sedan so that it seals properly at the rear of the door, try the following procedure:

1. Remove the door panel as described on page 20-3 of the S/M.
2. Loosen the two roller guide bolts and the four regulator/motor bolts.
3. Lower the glass a few millimeters. Lift the front of the glass up and push the rear of the glass back into the run channel. Hold the glass in this position.
4. First, tighten the rear roller guide bolt (it should be at the bottom of its adjustment slot). Next, tighten the front roller guide bolt (it should be at the top of its hole). Finally, tighten the four regulator/motor bolts (they should be about 1/32" from the bottom of their adjustment slots).

NOTE: If the door glass doesn't seal in the "A" pillar or mirror area, adjust the roller guide in the opposite direction.
