## GS-R Uses Different A/C Kit

**ACURA ServiceNews**

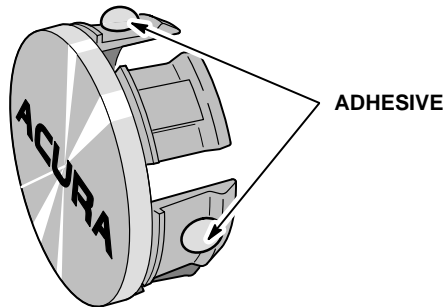
Some of the alloy wheel center caps on early '92 Integras don't fit tightly enough. ("Early" means through VIN JH4DB1 . . . NS002697 or JH4DA9 . . . NS009765.) If one of these cars comes in missing a cap, test the other caps by trying to remove them with a piece of duct tape wrapped around your hand. If the tape pulls the cap out, apply three equally spaced dabs of 3M Weatherstrip adhesive to the cap before you reinstall it. New replacement caps, however, fit tighter and need not be glued.

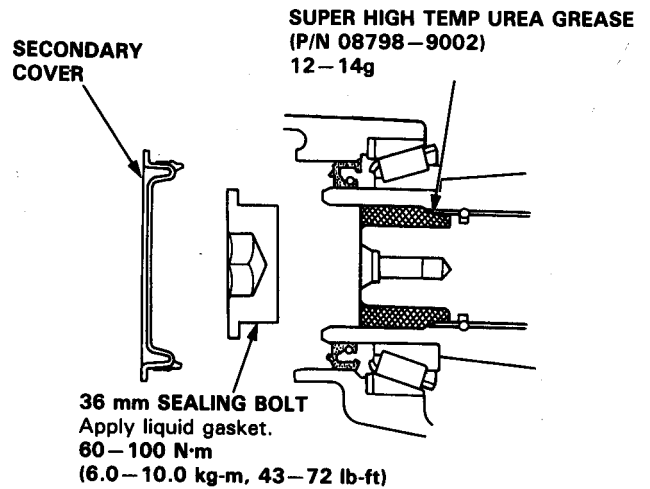
When installing the extension shaft on a '91-'92 Legend or '92 Vigor, don't forget to grease the splines and coat the sealing bolt threads with liquid gasket. Without both of these preventative measures, the splines may rust and seize, making any future trans or differential removal very difficult.

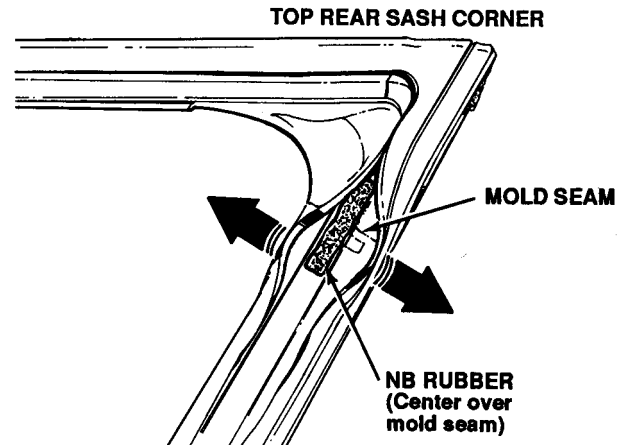
If the noise can't be eliminated by adjusting the roller guide, check for a deformed or improperly installed run channel. The run channel won't seal unless it's fully engaged with the door frame.

Replace the run channel if it's deformed. Add the reinforcement to the upper rear corner of the new run channel if it doesn't already have it (see above-mentioned S/B 91-012).

Before installing the new run channel, inspect the door frame spot welds. If the welds protrude and deform the run channel, flatten them with a drift.

Lubricate the run channel with silicone spray or WD-40. Install the upper section by pressing the lower lip in with a dull instrument. Test drive the car and adjust the glass for the least noise.
