ACURA ServiceNews

BSN 15531 (9210)

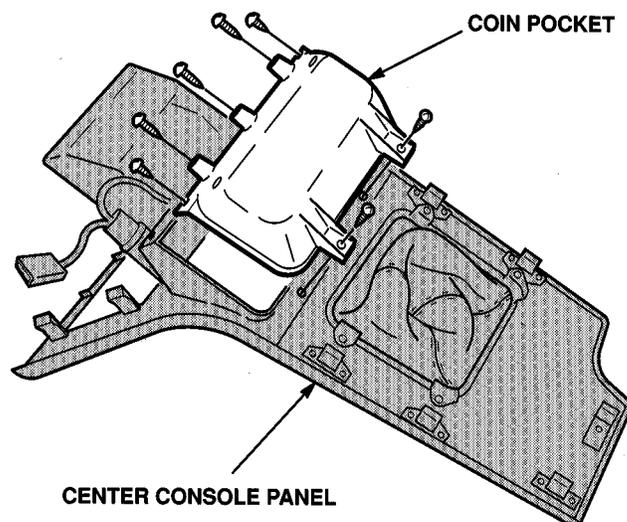
If you come across a '91-92 Legend with damaged center console screw holes (the ones right below the ashtray), you don't have to replace the whole center console panel. What's actually damaged is the coin pocket, which is available separately, P/N 77297-SP0-A00.

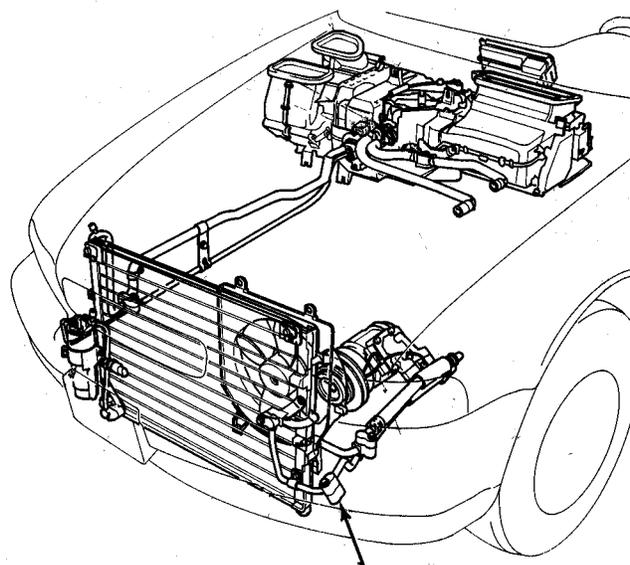
Complaint/Symptom: A/C stops cooling intermittently.

Corrective Action: After extensive checking, we removed the lower condenser line. Found a screw in the end of the line that would restrict the refrigerant flow at times. Removed the screw, and evacuated and recharged the system.

Screw found in this fitting.
