ACURA ServiceNews

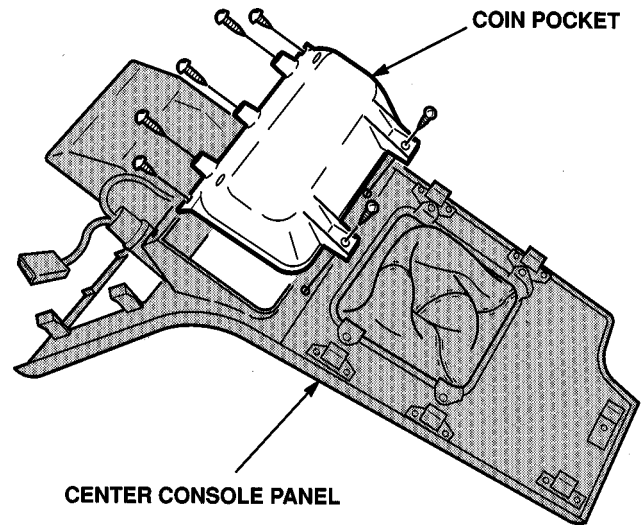
Legend Coin Pocket Availability

If you come across a '91-92 Legend with damaged center console screw holes (the ones right below the ashtray), you don't have to replace the whole center console panel. What's actually damaged is the coin pocket, which is available separately, P/N 77297-SP0-A00.

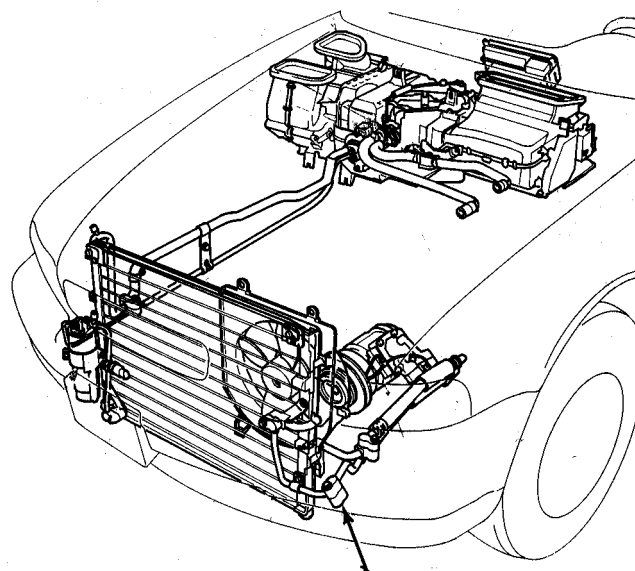
Complaint/Symptom: A/C stops cooling intermittently.

Screw found in this fitting.

Corrective Action: After extensive checking, we removed the lower condenser line. Found a screw in the end of the line that would restrict the refrigerant flow at times. Removed the screw, and evacuated and recharged the system.
