### ACURA ServiceNews

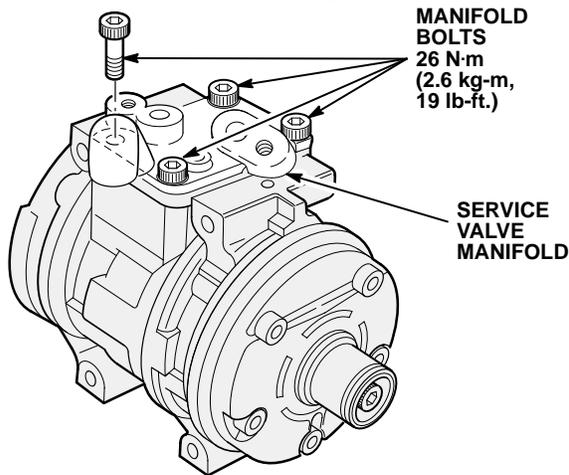
Replacement Nippondenso (ND) A/C compressors don't come with a new service valve manifold (the plate where the suction line, discharge line, and relief valve attach). Transfer the manifold from the old compressor to the new compressor. (Use the new O-ring included with the compressor.) Torque the manifold bolts to 26 N·m (2.6 kg-m, 19 lb-ft).

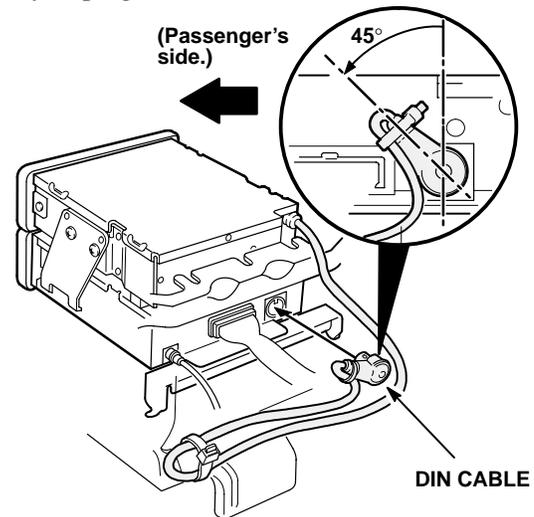
When installing a CD player or changer in a '94 Integra, beware: It is possible (if you've been eating your Wheaties) to plug in the DIN connector wrong (45 degrees off). With the RS audio unit, this means the CD player won't work. With the LS/GS-R audio unit, however, this means the audio unit will never work again! Make sure the DIN lead points toward the passenger's side of the car at a 45-degree angle when you plug in the connector.

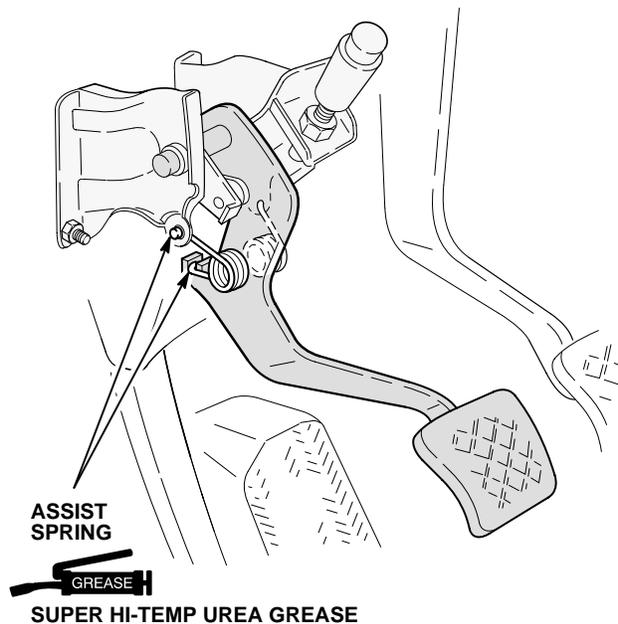
A "spring noise" when you slowly depress and release the clutch pedal on a '91-94 Legend or '92-94 Vigor may be caused by a dry clutch pedal assist spring. Lubricate the assist spring pivot points with Super Hi-Temp Urea Grease, P/N 08798-9002, where shown.
