ACURA ServiceNews

BSN 16053 (9308)

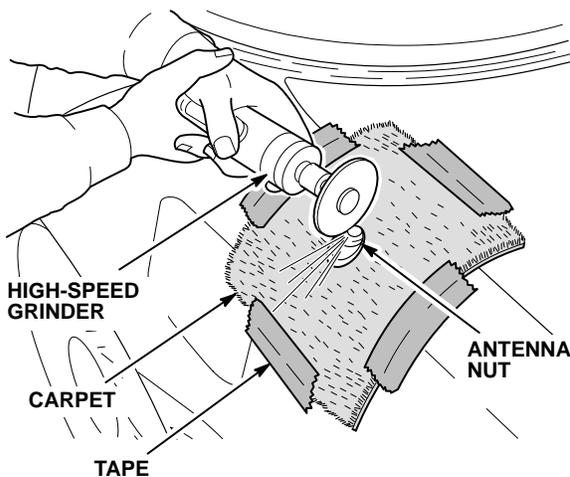
When there's corrosion between the antenna nut and mast housing threads, it's sometimes impossible to remove the nut with an antenna nut wrench. If you find yourself in this situation, try the following:

1. Make sure you have the proper new antenna assembly, insulator, and antenna nut on hand.
2. Cut a 1-inch hole in the middle of a large, surplus piece of indoor-outdoor carpet (or something similar). Slip the hole over the antenna, and tape the carpet to the body.
3. Using a cut-off wheel in a high-speed grinder, cut through one side of the antenna nut.

4. Spread the antenna nut apart with a flat tip screwdriver, then remove it from the mast housing.
5. Remove the old antenna assembly.
6. Install the new antenna assembly, adapter, and antenna nut.

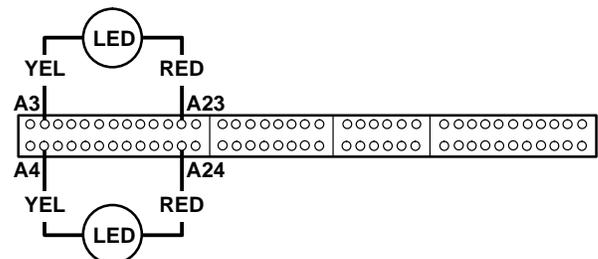
In the July '92 issue of S/N, we did an article on checking Vigor A/T shift solenoid signals while you drive ("Shift Problem: Trans or Control Unit?"). In the November '92 issue, we told you how to perform the same check on a '91-93 Legend. However, we reversed the terminal connections in the illustration of the Legend article, although the text was correct. (Do as we say, not as we illustrate?) So here it is again, with the correct illustration:

Connect LED A to terminals A23 (+RED) and A3 (-YEL), and LED B to A24 (+RED) and A4 (-YEL). Staple a photocopy of *this* Legend illustration to your July '92 issue.

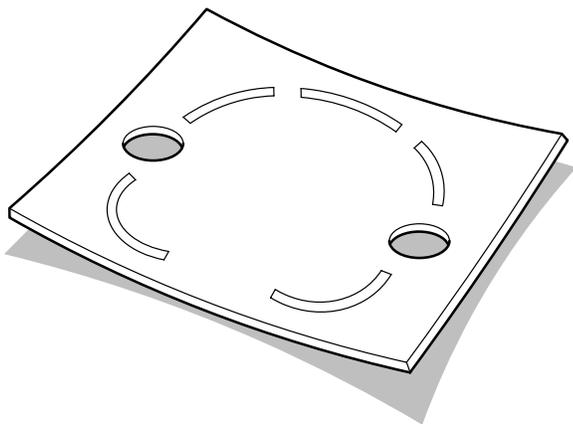
Early-production tweeter kits for '94 Integras include a template for cutting the tweeter hole in the door panel. As you've probably noticed, however, the installation instructions don't mention a template. Don't worry, the instructions aren't missing anything; the installation procedure was changed to eliminate the use of the template.
