Latest PGM Tester Software Is SN010P

ACURA ServiceNews

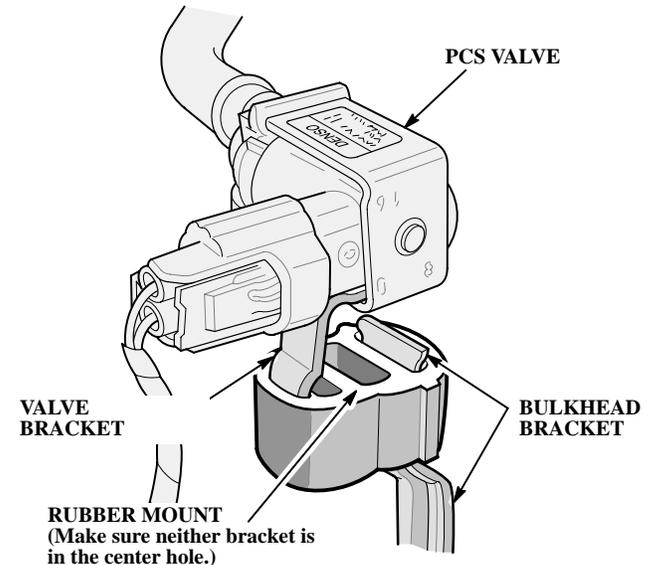
Clicking PCS Valve: '00 3.2TL

If you have a clicking purge control solenoid (PCS) valve on a '00 3.2TL, check the valve's installation. It's attached to the bulkhead with a three-holed rubber mount above the brake booster. A correctly installed valve has the bulkhead bracket in one end of the mount, and its own bracket in the other. To minimize the clicking, make sure neither bracket is in the center hole.

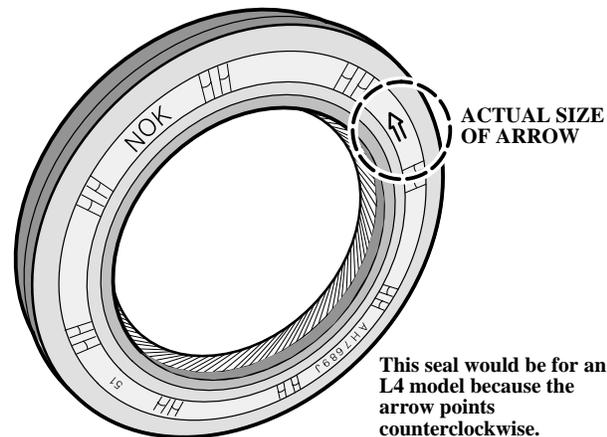
Leaking Torque Converter

An ATF leak that usually shows up between 8,000 and 15,000 miles may be caused by the wrong torque converter oil seal. (See the 11/99 and 12/99 issues of S/N for more info on the seal.)

If you find that the wrong seal was installed (the small arrow on its face should point clockwise on V6 models and counterclockwise on L4s), you can replace it without disassembling the trans. Just refer to S/B 00-008, *Torque Converter Oil Seal Installation Tool*, filed under Tools, and install the correct seal with the new seal driver attachment and your 40 mm driver.
