A/C Capacities: '90 Thru '98 Models

ACURA ServiceNews

BSN 19644 (9805)

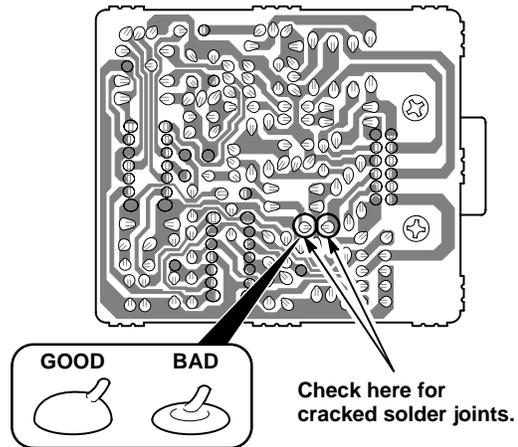
PRINTED CIRCUIT BOARD

If a '91-'93 Legend blows warm air intermittently, do the procedure in S/B 95-020, *A/C Blows Warm Air Intermittently* (filed under Heater-A/C in your S/B binder). Here's a summary of the S/B procedure. For details (including VIN breaks and warranty info), refer to the S/B.

Remove the fan control unit from the ECM bracket, and look at its printed circuit board with a magnifying glass:

- If either of the solder joints (circled below) are cracked, replace the control unit (P/N 37735-PY3-901).
- If the solder joints are OK, do an A/C performance test to help you find and fix other possible causes of the problem.

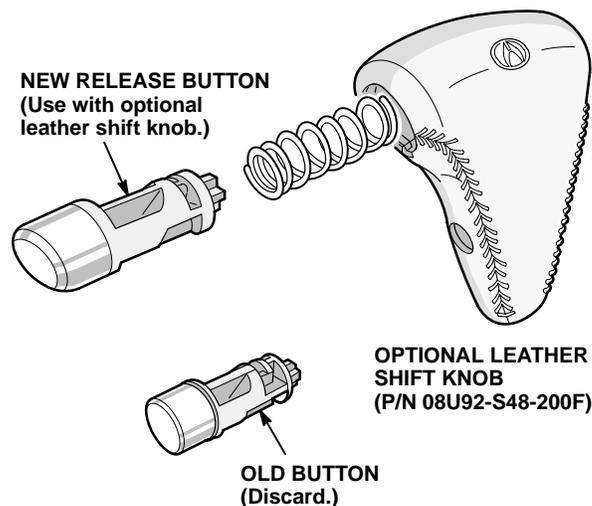
If you're installing an optional leather shift knob (P/N 08U92-SY8-200F) on a '98 CL with A/T, you need to replace the shift knob release button with P/N 54132-SV4-A81. The release button that comes standard on '98 CLs won't work.

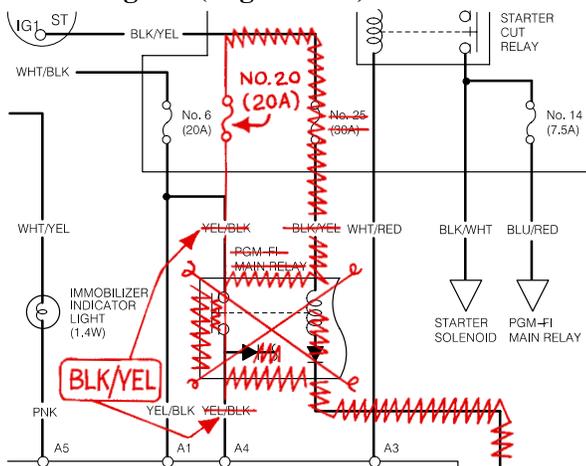
Circuit Diagram (Page 23-158):

The PGM-FI main relay isn't a part of the 3.5RL immobilizer system, even though it's shown that way in the '96-98 3.5RL S/M. Please correct the immobilizer circuit diagram and the control unit input test like this:

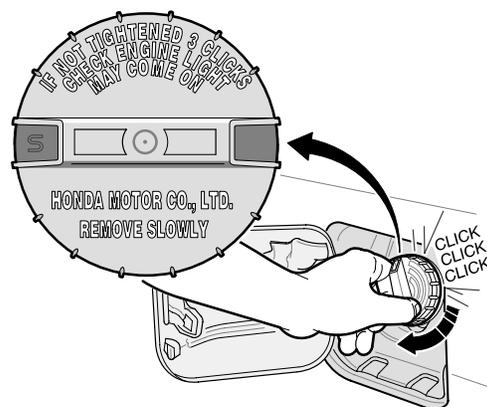
To prevent the MIL from coming on and storing DTC P1456 (Code 90), the fuel fill cap must be tight. The on-board diagnostic (OBD II) system on affected vehicles is sensitive to anything that might be considered a leak, including a loose cap.

On most '98 vehicles, a tightening precaution is printed right on the cap.

Remind your customers to tighten the cap until it clicks at least three times. It's impossible to over-tighten the cap because it ratchets when it's tight. We suspect that when some customers tighten the cap after refueling, they hear it click, and then back it off (thinking that it's too tight).
