Wind Noise From Door Glass

(Supersedes 91-012, dated February 2, 1992)

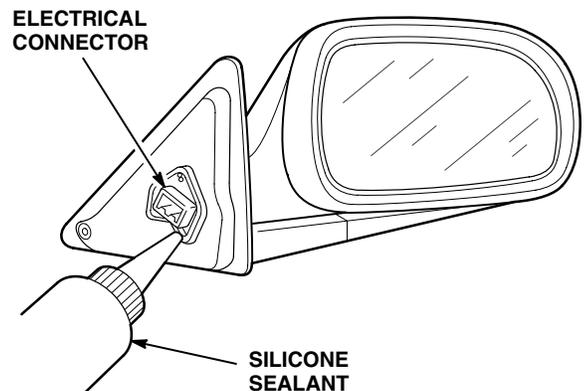
Remove the inner cover panel, test drive the car, and use a stethoscope to listen for an air leak around the mirror electrical connector. If you find an air leak, seal the electrical connector with silicone sealant.

- Apply silicone sealant around the edge of the electrical connector to seal it to the mirror frame.
