ACURA ServiceNews

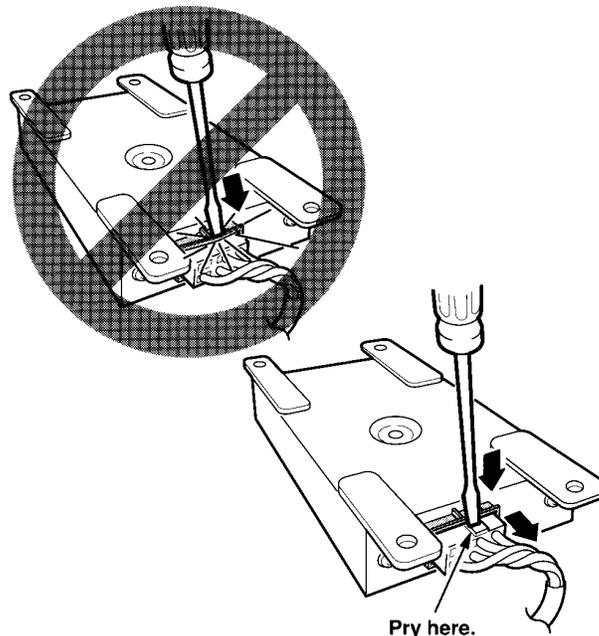
Then, when removing the connectors from the unit, don't pry them out with a screwdriver; they're tight, but they can be pulled by hand. If you can't remove them without prying, make sure you pry on the wire harness side of the connector, as shown. (Use a flashlight and look at the connector before you attack it.) Some people pry on the control unit half of the connector, which breaks easily, and makes it impossible to remanufacture the unit.

First, run the seat up to the maximum height so you'll have more room to work around the control unit.

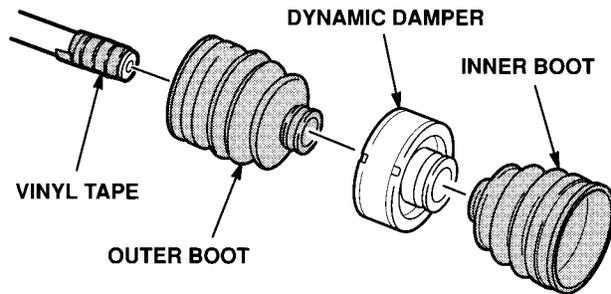
Although S/B 92-009, "Clicking Noise While Turning," describes how to replace an outer CV joint, don't use this procedure to replace an outer CV joint boot. The severe impacts required to remove the outer joint will damage the joint bearings, so never reuse an outer CV joint. To replace an outer CV boot, use the following procedure:

1. Remove the driveshaft as described in section 16 of the appropriate S/M.
2. Remove and discard the boot bands from both boots.
3. Remove the inner joint, circlip, rollers, and spider.
4. Remove the inner boot, dynamic damper, and outer boot. Discard both boots.
5. Wrap the splines with vinyl tape. Slide the outer boot down the shaft, then install and secure the outer boot bands.

6. Install the dynamic damper, inner boot, and inner boot bands, but don't secure the bands yet.
7. Remove the vinyl tape. Install the spider, rollers, circlip, and inner joint.
8. Secure the inner boot bands.
9. Reinstall the driveshaft using a new spindle nut.
NOTE: If you need to add grease to the CV joints, use Inner CV Joint Grease, P/N 08798-9003, and Outer CV Joint Grease, P/N 08798-9004.
