## Integra Front Door Glass Chatters

## Repair Loose Quarter Window Trim

## Silicone Shrinks NSX Windshield Molding

### ACURA ServiceNews

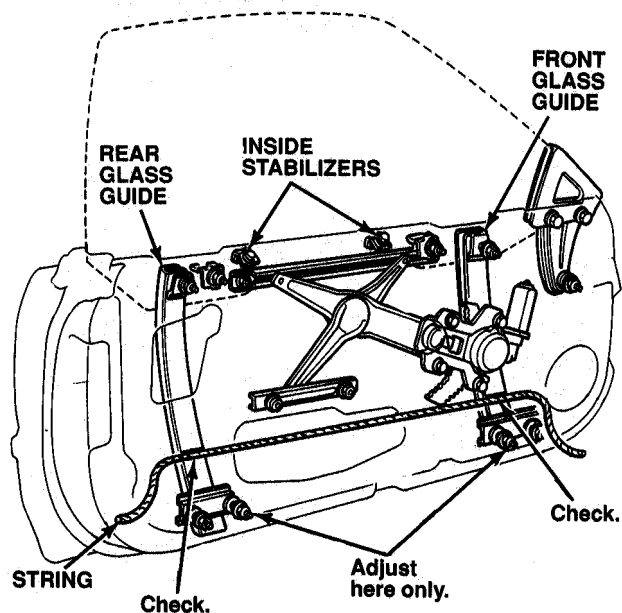
A “chatter” when the front door glass is raised and lowered on a '90-93 Integra can usually be eliminated by realigning the glass guides and regulator.

1. Remove the door panel as described in the S/M.
2. Remove the four window regulator motor mounting bolts.
3. Shim the regulator motor 2 mm away from the door skin: Insert a 2 mm thick washer between the door skin and the regulator motor at each mounting bolt location, then reinstall the mounting bolts.
4. Make sure the front and rear glass guides are parallel with each other longitudinally: Run a string from the leading edge of the front glass guide to the trailing edge of the rear glass guide. If the guides are parallel, the string will lay flat against both guides.

5. If the guides are not parallel, adjust them as necessary until the string lays flat. To avoid changing the glass camber, adjust only the *rear* adjusting bolt on the front guide, and the *front* adjusting bolt on the rear guide.
6. Once the guides are parallel, turn the adjusting bolts described above two full turns counterclockwise, then tighten the locknuts.
7. With the door glass lowered fully, make sure the inside stabilizers touch the glass lightly, then reinstall the door panel.

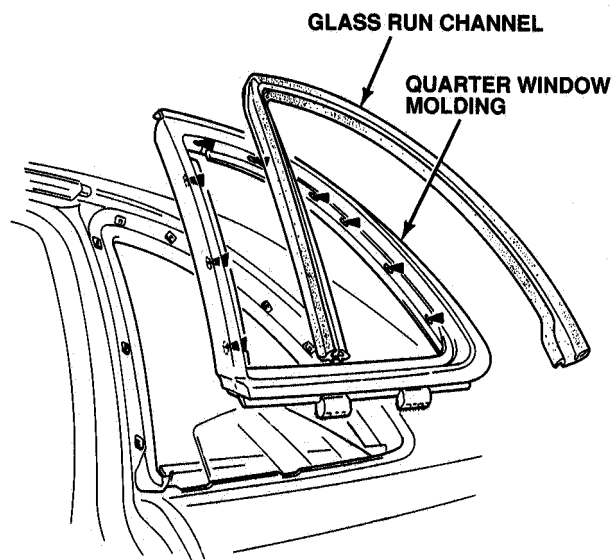
If the outer rubber trim on a '91-92 Legend Coupe quarter window molding is loose and sticking out, repair it as follows. (Replace the quarter window molding assembly only if the rubber trim is missing.)

1. Lower the quarter glass fully.
2. Peel the glass run channel out of the quarter window molding.
3. Remove the nine screws, then remove the quarter window molding.

4. Clean the quarter window molding and the outer rubber trim with adhesive remover, then reattach the trim with cyanoacrylate adhesive (“Super Glue”).
5. Reinstall the quarter window molding and the glass run channel.

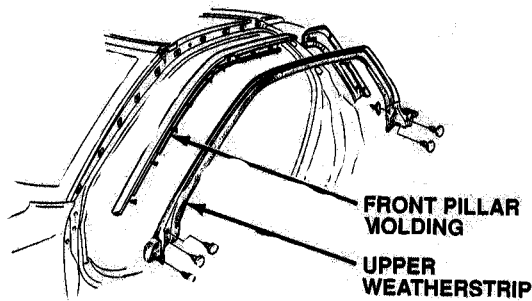
In the "Creak from NSX Windshield/Dash" article in the May '92 issue of S/N, we mentioned installing the upper windshield molding "with a dose of silicone lubricant." Since then, we've found it's best to use dishwashing soap or tire mounting lube instead of silicone. Silicone stays too slippery, and may allow the upper windshield molding to "shrink" and pull away from the front pillar moldings. Here's the easiest way to replace a shrunken molding:

1. Remove both door glass weatherstrips and front pillar moldings.

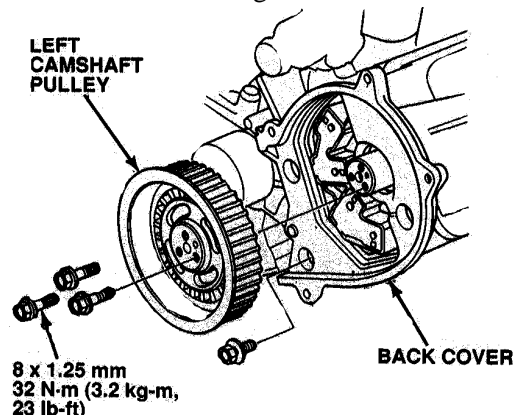
Two steps are missing from the water pump replacement procedure on page 10-9 of the '91-93 Legend S/Ms. Add these steps after step 2 (timing belt removal):

- 2a. Remove the left camshaft pulley.
- 2b. Remove the left timing belt back cover.
