YEAR
1991 - 92

MODEL
LEGEND 4-DOOR

BULLETIN NO.
92-025

Rear Side Window Molding End Cap Replacement

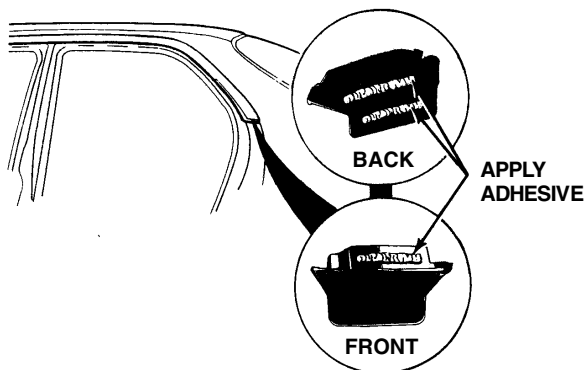
The rear side window (C pillar) molding end caps are missing or loose.

The adhesive between the end cap and the molding has hardened and disintegrated.

1. Remove caps if necessary.
2. Dampen a cloth with Contact Cleaner (P/N TB-SP-270TA).
Clean the inside of the C pillar molding and the painted surface just below it.
3. Apply Weatherstrip Cement (P/N 08712-0002), or equivalent, to the front and back sides of the end cap.

4. Install molding end caps.
