## Easy Hinge and Latch Maintenance

### ACURA ServiceNews

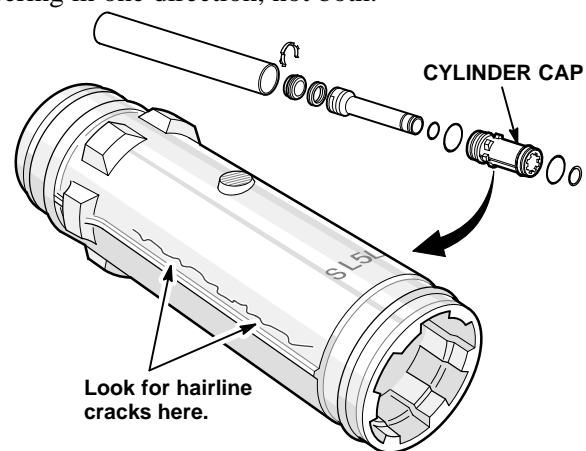
A '91-95 Legend or '92-94 Vigor with normal power steering assist on right turns, but reduced assist on left turns may have a cracked cylinder cap inside the power steering gearbox. The cylinder cap directs fluid from the 4-way control valve (in the valve body) to the left or right side of the steering rack piston. If it's cracked, fluid pressure to the piston is reduced, and so is the assist. A cracked cap usually affects steering in one direction, not both.

To correct this condition, you need to disassemble the steering gearbox and replace the cylinder cap. Refer to the appropriate S/M for rack overhauling instructions.
