## ACURA ServiceNews

BSN 14597 (9105)

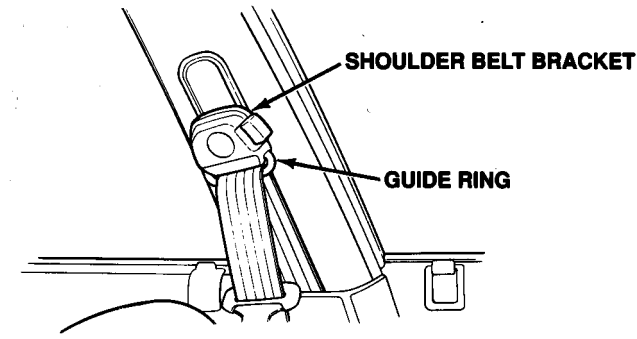
## Slow Seat Belt? Clean the Guide Ring

A common cause of a slow retracting seat belt is a dirty guide ring on the shoulder belt bracket.

To confirm the cause, pull the shoulder belt out just above the trim panel, below the shoulder belt bracket (so the guide ring won't affect how the belt retracts). Release the belt and observe how quickly it retracts. Now pull the shoulder belt out by the tongue plate (as you would normally) and observe how quickly it retracts. If the belt retracts slower the second time, chances are there's a build-up of dirt on the guide ring.

To remove the build-up, wipe the guide ring's sliding surface with some isopropyl alcohol. The best method is to dampen a thin piece of linen cloth with alcohol, then run it between the belt and the ring.

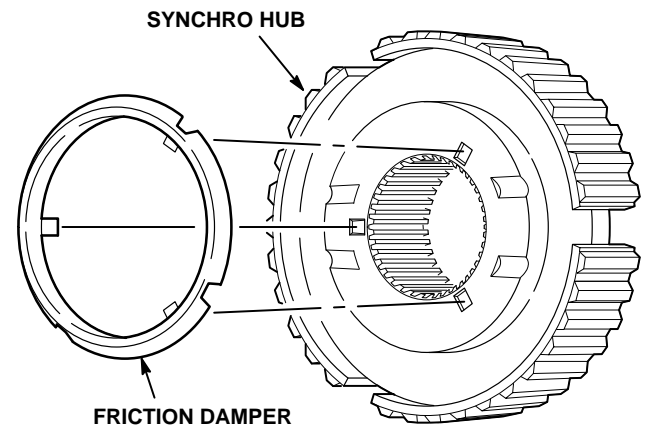
## Legend M/T Assembly Tips

When assembling the countershaft for a '91 Legend M/T, make sure the drive tabs on the friction dampers engage the notches in the 1<sup>st</sup>/2<sup>nd</sup> synchro hub. There are two friction dampers: one for 1<sup>st</sup> gear, and one for 2<sup>nd</sup> gear. Each damper has three drive tabs that correspond with the three notches in either side of the 1<sup>st</sup>/2<sup>nd</sup> synchro hub. The dampers reduce "roll over noise" (gear lash noise) when the engine is idling with the trans in neutral and the clutch engaged.

Once the drive tabs are engaged with the notches, don't separate the gear and hub, and/or turn the countershaft or gear. If you do, the tabs will disengage, and the damper will turn with the gear (due to friction) while the synchro hub turns with the shaft (they're splined). If the tabs aren't in the notches, they get pinched between the gear and hub as you assemble the trans. Then, after you install the trans and drive the car, the tabs get torn off under power. This throws the countershaft clearances off (because the tabs were pinched), and you'll probably experience grinding during shifts, and/or slipping out of gear.

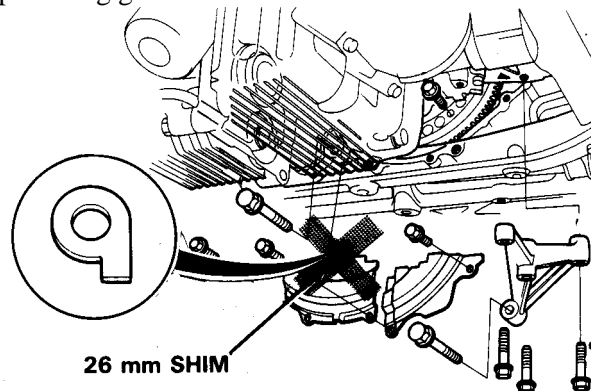
## Legend Trans/Diff Shim Position

All '91 Legends (and Vigors too, for that matter) use a select-fit 26 mm shim at the trans-to-differential mounting bolt hole. This shim, however, is pictured upside down in the A/T section of the '91 Legend Sedan S/M (pages 14-96 and 14-158). So take note: be sure the shim's tab points *down* when installing this shim; otherwise, the tab may hit the drive plate/ring gear.
