Slow Seat Belt? Clean the Guide Ring

NSX Fender Covers

Vigor Service Check Connectors

Legend M/T Assembly Tips

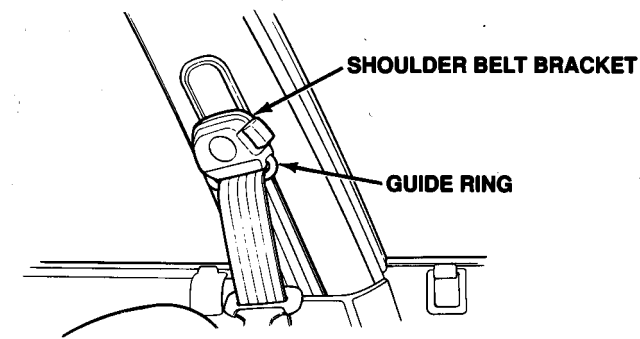
A common cause of a slow retracting seat belt is a dirty guide ring on the shoulder belt bracket.

To confirm the cause, pull the shoulder belt out just above the trim panel, below the shoulder belt bracket (so the guide ring won't affect how the belt retracts). Release the belt and observe how quickly it retracts. Now pull the shoulder belt out by the tongue plate (as you would normally) and observe how quickly it retracts. If the belt retracts slower the second time, chances are there's a build-up of dirt on the guide ring.

To remove the build-up, wipe the guide ring's sliding surface with some isopropyl alcohol. The best method is to dampen a thin piece of linen cloth with alcohol, then run it between the belt and the ring.

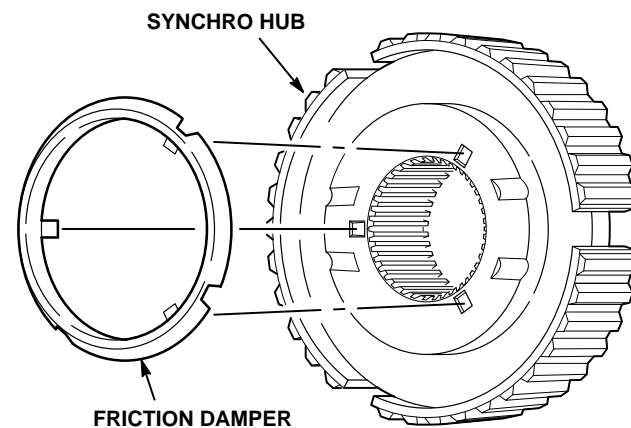
When assembling the countershaft for a '91 Legend M/T, make sure the drive tabs on the friction dampers engage the notches in the 1st/2nd synchro hub. There are two friction dampers: one for 1st gear, and one for 2nd gear. Each damper has three drive tabs that correspond with the three notches in either side of the 1st/2nd synchro hub. The dampers reduce "roll over noise" (gear lash noise) when the engine is idling with the trans in neutral and the clutch engaged.

Once the drive tabs are engaged with the notches, don't separate the gear and hub, and/or turn the countershaft or gear. If you do, the tabs will disengage, and the damper will turn with the gear (due to friction) while the synchro hub turns with the shaft (they're splined). If the tabs aren't in the notches, they get pinched between the gear and hub as you assemble the trans. Then, after you install the trans and drive the car, the tabs get torn off under power. This throws the countershaft clearances off (because the tabs were pinched), and you'll probably experience grinding during shifts, and/or slipping out of gear.
