**ACURA** ServiceNews

BSN 18662 (9703)

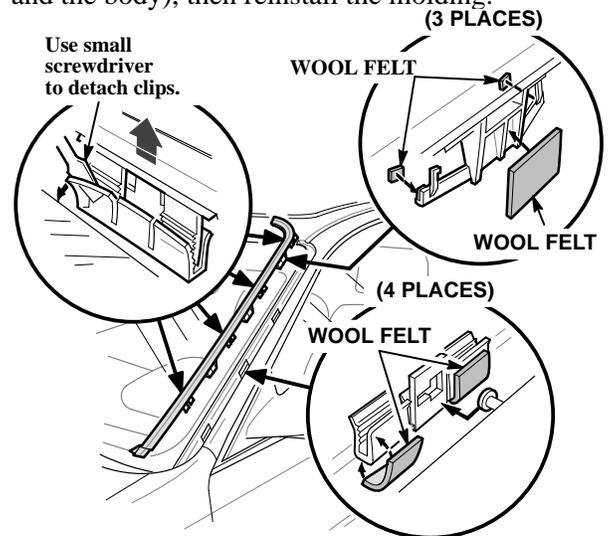
On '97 2.2CLs (thru VIN 19UYA1 . . . VL008556), follow the procedure in S/B 96-053, *Pop or Creak From the Right Side of the Dashboard*, to fix a dashboard creak. (The S/B describes how to install a piece of EPDM foam between the dashboard and windshield. Actually, it applies to both the right and left sides.) If this doesn't stop the creak, do these additional steps:

1. Remove the A-pillar side molding on the side with the creak, then test-drive the car. If you still hear the noise, go to step 2.
2. Apply wool felt to each trim clip (between the clip and the body), then reinstall the molding.

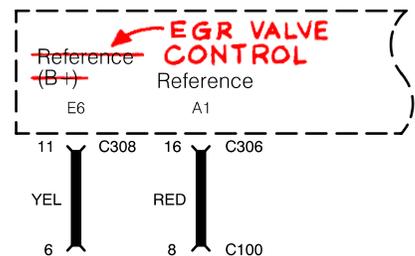
TOP RIGHT SIDE OF PAGE:

Before you troubleshoot the fuel injection system on a '96 SLX, switch two of the PCM terminal references on page 23-4 of the '96 SLX ETM. Pin E6 should be for EGR valve control, and Pin B7 is for EGR feedback control input. Mark the ETM page like this:

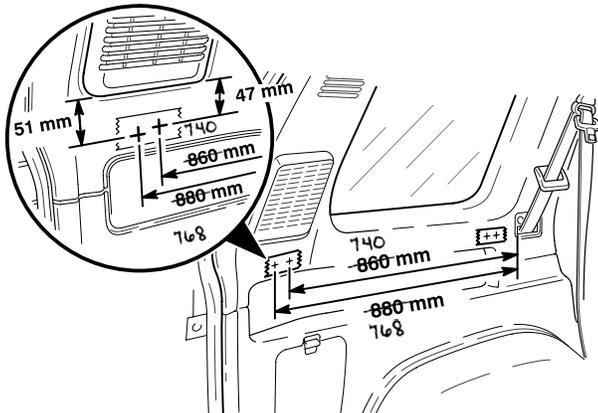
In step 4 of the '97 SLX Cargo Cover Installation Instructions, some of the dimensions in the second illustration are incorrect. Please write in the corrected dimensions as shown below.
