A/C Compressor Shims and Seals

ACURA ServiceNews

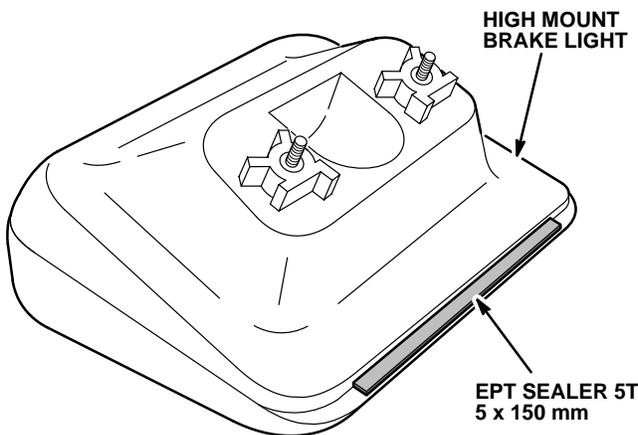
Coupe High Mount Brake Light Rattle

The rear edge of the high mount brake light on a '91 Legend Coupe can rattle against the rear shelf. If you come across a car with this noise, the following procedure will get rid of it:

1. From inside the trunk, remove the bulb socket and the two mounting nuts from the high mount brake light.
2. Remove the high mount brake light from the rear shelf and turn it upside down.
3. Cut a 5 x 150 mm piece of 5 mm thick EPT Sealer.
4. Center and apply the EPT to the bottom of the light housing, along the rear edge, as shown.

5. Reinstall the high mount brake light as close to the rear window as possible, tighten the mounting nuts, and reinstall the bulb socket.

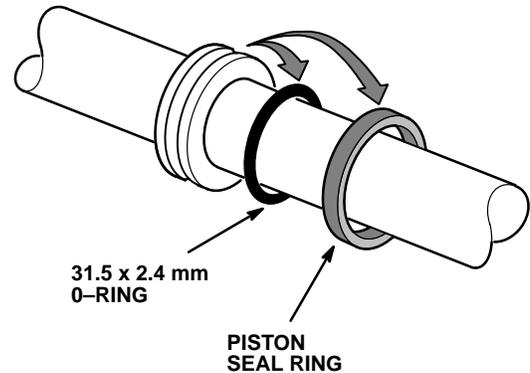
Legend Steering Rack Rebuilding

When you're rebuilding a steering rack on an '86 Legend, don't use the piston seal ring or the triangular 31.5 x 2.4 mm O-ring that are in the P/S Rack Seal Kit, P/N 065A3-SD4-415. The triangular O-ring and the piston seal ring in the kit are used only on '87-90 Legends; the '86 Legend uses the round O-ring and the corresponding piston seal ring listed below:

O-ring, 31.5 x 2.4 mm (round): P/N 91356-SD4-952

Piston Seal Ring: P/N 53629-SD4-951

Luckily, however, if you're just resealing a leaky rack, instead of doing a complete overhaul, it's not really necessary to replace the piston seal ring and O-ring. If the piston seal ring or its O-ring were the problem, the complaint would be poor assist in both directions, not leakage.

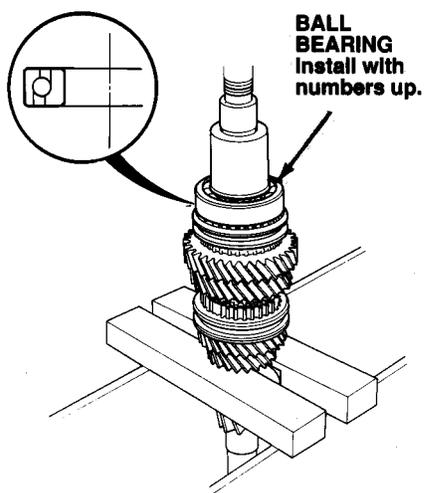
Integra M/T Bearing Installation

The ball bearing on the 5th gear-end of the mainshaft in a '90-91 Integra is a directional bearing (i.e., it must be installed in the right direction). The Mainshaft Assembly Index page illustration indicates this, but it's easy to overlook. We'd suggest that you make a note near step 3 on page 13-27:

Install the bearing with the manufacturing numbers facing up, away from 5th gear.
