## Parasitic Draw Test Clarifications

## ACURA ServiceNews

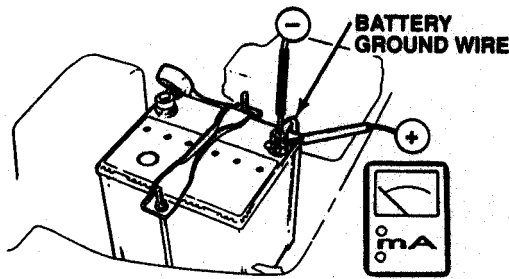
To measure parasitic draw, make sure the doors are closed, all electrical components are off, and the ignition switch has been turned off for at least five minutes (for passive belt timers to reset). Loosen, but do not remove, the negative battery terminal. With your ammeter on the 10A scale, touch the negative ammeter lead to the negative battery post and touch (or connect) the positive ammeter lead to the negative battery cable terminal.

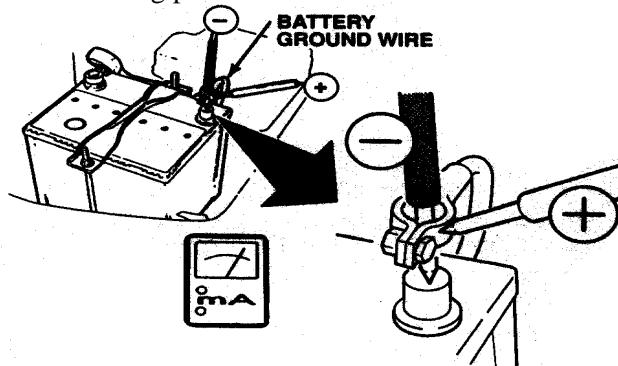
Now, without breaking the contact between the test leads, battery post, and battery cable, carefully lift the negative cable off the negative post. The ammeter is now in series with the electrical system and is reading parasitic draw.

If the reading is less than 0.2A (200 mA), put the cable back on the post, change the ammeter range and leads to 200 mA, and lift the cable off the post again to get a more precise reading. If the reading exceeds the specs in the S/B, isolate the source of the draw by removing fuses and disconnecting components as described in the bulletin.

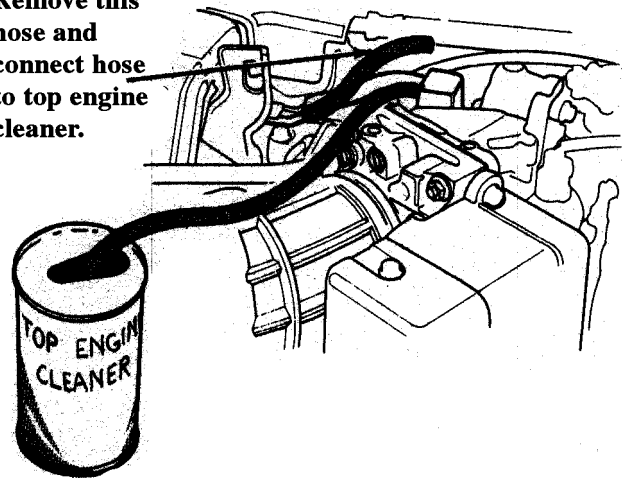
Excessive carbon build-up on the pistons of '91 Legends may cause a loud metallic knocking noise when the engine is cold. The noise can usually be heard between 1,200 – 1,500 rpm, but it goes away as the engine warms up.

**Remove this hose and connect hose to top engine cleaner.**

To remove the carbon deposits, use a liquid top engine cleaner (GM Top Engine Cleaner, #105002, works well). To draw the cleaner into the engine, remove the hose next to the #21 hose on the throttle body base.

Connect a piece of hose long enough to immerse into the can of cleaner to the port on the throttle body base. Start the engine, keeping it at 800 – 1,000 rpm, then immerse the hose into the cleaner. Run the engine until all the cleaner has been drawn in, then immediately shut off the engine. Let the car sit for 1-2 hours, then drive it in the lower gears at higher rpm to remove the carbon loosened by the cleaner. (Reconnect the vacuum hose before you drive the car.)

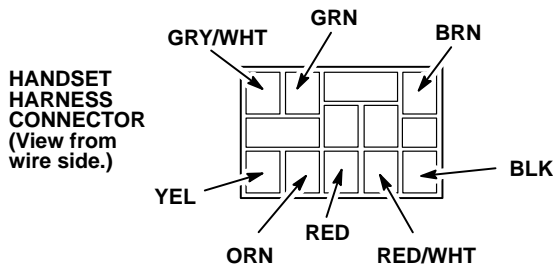
If a genuine-accessory cellular phone won't power up or the handset display won't work immediately after installation in a '91-92 Legend, check the handset harness. (The handset harness is P/N 08E04-SP0-20004; #18 on the parts illustration in the installation instructions.) When the handset harness connector is viewed from the wire side, the wires should be in the following positions.

If any of the wires are out of position, move them to the correct cavities.

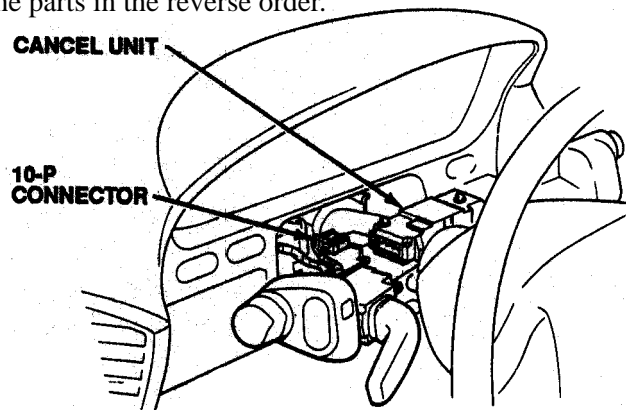
A poor connection in the turn signal cancel unit on an NSX may cause the turn signals to cancel too soon. "Too soon" usually means when you're still turning the steering wheel in the direction of the turn.

To correct this problem, first remove the tilt cover and the steering column covers. Now remove the cancel unit and its micro-switch. Remove the microswitch cover, clean the contacts, and bend them slightly to increase the contact pressure. Reassemble the parts in the reverse order.
