## Parasitic Draw Test Clarifications

## ACURA ServiceNews

BSN 15229 (9205)

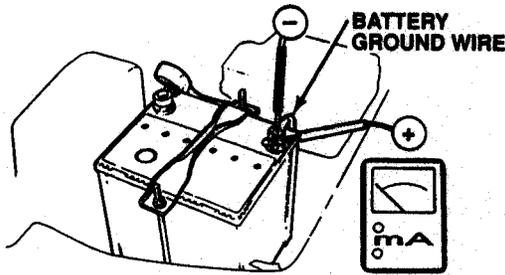
To measure parasitic draw, make sure the doors are closed, all electrical components are off, and the ignition switch has been turned off for at least five minutes (for passive belt timers to reset). Loosen, but do not remove, the negative battery terminal. With your ammeter on the 10A scale, touch the negative ammeter lead to the negative battery post and touch (or connect) the positive ammeter lead to the negative battery cable terminal.

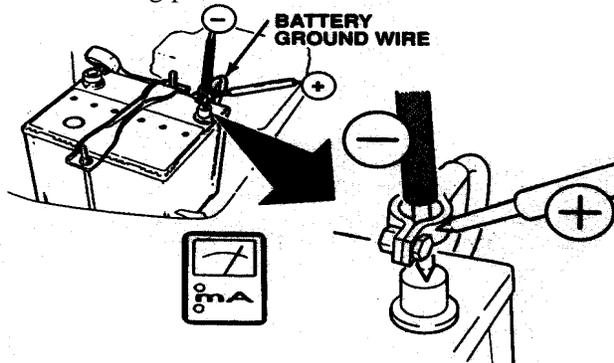
Now, without breaking the contact between the test leads, battery post, and battery cable, carefully lift the negative cable off the negative post. The ammeter is now in series with the electrical system and is reading parasitic draw.

If the reading is less than 0.2A (200 mA), put the cable back on the post, change the ammeter range and leads to 200 mA, and lift the cable off the post again to get a more precise reading. If the reading exceeds the specs in the S/B, isolate the source of the draw by removing fuses and disconnecting components as described in the bulletin.

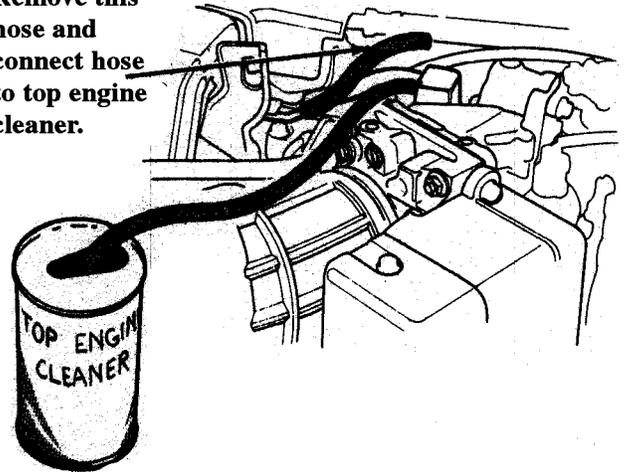
Excessive carbon build-up on the pistons of '91 Legends may cause a loud metallic knocking noise when the engine is cold. The noise can usually be heard between 1,200 – 1,500 rpm, but it goes away as the engine warms up.

**Remove this hose and connect hose to top engine cleaner.**

To remove the carbon deposits, use a liquid top engine cleaner (GM Top Engine Cleaner, #105002, works well). To draw the cleaner into the engine, remove the hose next to the #21 hose on the throttle body base.

Connect a piece of hose long enough to immerse into the can of cleaner to the port on the throttle body base. Start the engine, keeping it at 800 – 1,000 rpm, then immerse the hose into the cleaner. Run the engine until all the cleaner has been drawn in, then immediately shut off the engine. Let the car sit for 1-2 hours, then drive it in the lower gears at higher rpm to remove the carbon loosened by the cleaner. (Reconnect the vacuum hose before you drive the car.)

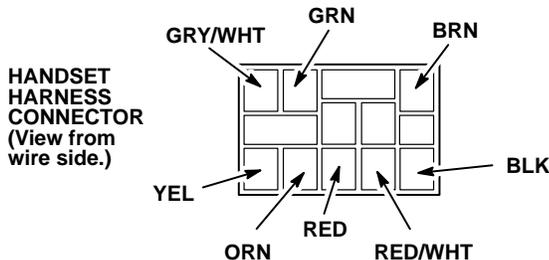
If a genuine-accessory cellular phone won't power up or the handset display won't work immediately after installation in a '91-92 Legend, check the handset harness. (The handset harness is P/N 08E04-SP0-20004; #18 on the parts illustration in the installation instructions.) When the handset harness connector is viewed from the wire side, the wires should be in the following positions.

If any of the wires are out of position, move them to the correct cavities.

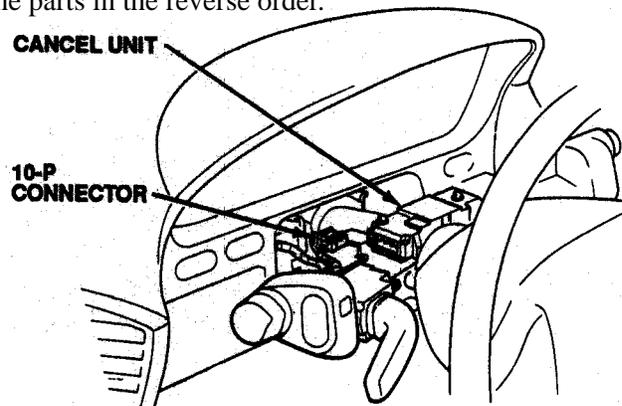
A poor connection in the turn signal cancel unit on an NSX may cause the turn signals to cancel too soon. "Too soon" usually means when you're still turning the steering wheel in the direction of the turn.

To correct this problem, first remove the tilt cover and the steering column covers. Now remove the cancel unit and its micro-switch. Remove the microswitch cover, clean the contacts, and bend them slightly to increase the contact pressure. Reassemble the parts in the reverse order.
