3.2TL Front Suspension Clunks

ACURA ServiceNews

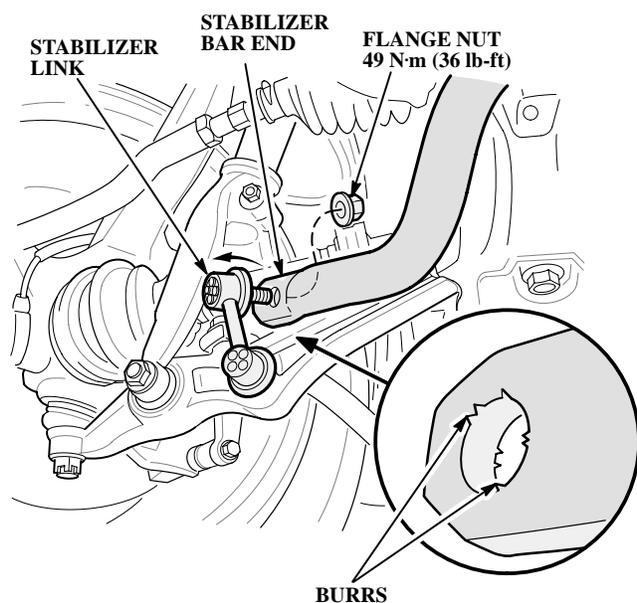
On '99-00 3.2TLs, if a customer complains that the vehicle clunks when turning or going over bumps, check to see if the flange nuts on the front stabilizer links are loose. If they are loose, disconnect them from the stabilizer bar ends, pivot them out of the way, and check the holes in the bar ends for burrs. A nut that's tightened against a burr can loosen as the burr flattens or changes shape. To keep this from happening again, remove any burrs with a file, and reconnect the stabilizer links to the bar ends. Torque the flange nuts to 49 N·m (36 lb-ft).

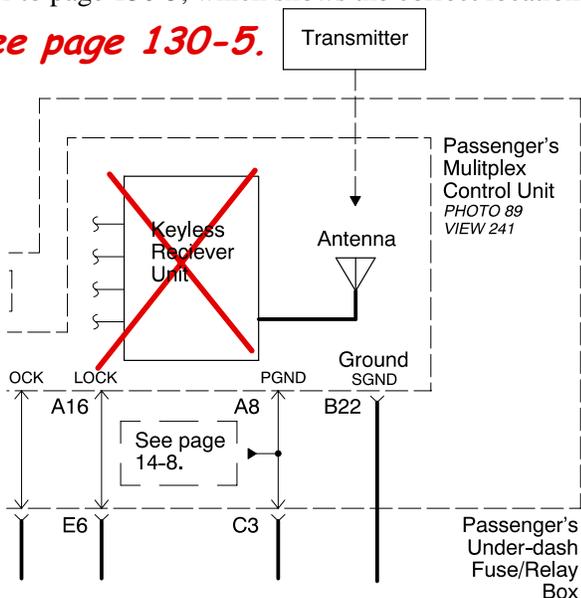
See page 130-5.

The circuit diagram on page 130-1 of the '01 3.2CL ETM shows an incorrect the location for the keyless receiver unit. Make a note on that page to refer to page 130-5, which shows the correct location.

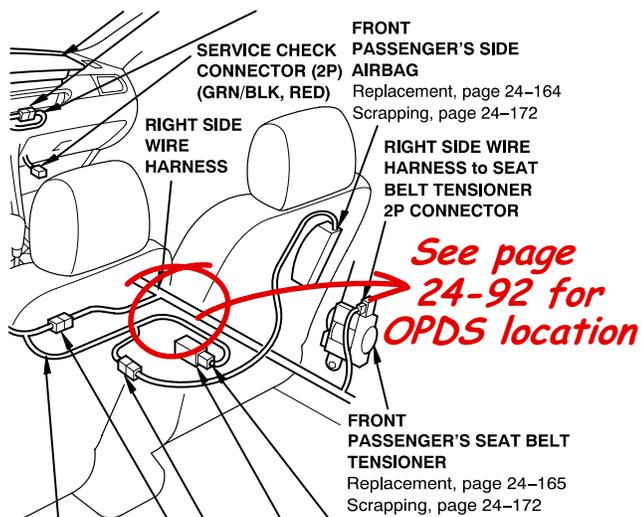
In the '96-00 3.5RL S/M, the component location index on page 24-15 doesn't show the occupant position detection sensor (OPDS) control unit in the front passenger's seat. Make a note on that page to refer to page 24-92.
