Legend Oil Leak from Front of Trans

ACURA ServiceNews

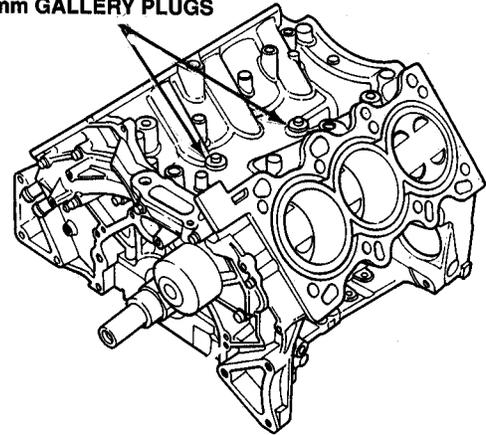
'8mm GALLERY PLUGS

An oil leak from the torque converter/clutch housing area on a '91 Legend may actually originate under the intake manifold. To confirm the source, push a shop towel under the intake manifold, then remove it. If it's wet with engine oil, remove the intake manifold and check the two 18 mm gallery plugs in the top of the block. If they're leaking, torque them to 60 N·m (6.0 kg-m, 44 lb-ft). If the 18 mm gallery plugs are OK, remove the intake manifold gaskets and check the two 10 mm gallery plugs on each head. If they're leaking, torque them to 20 N·m (2.0 kg-m, 14 lb-ft).

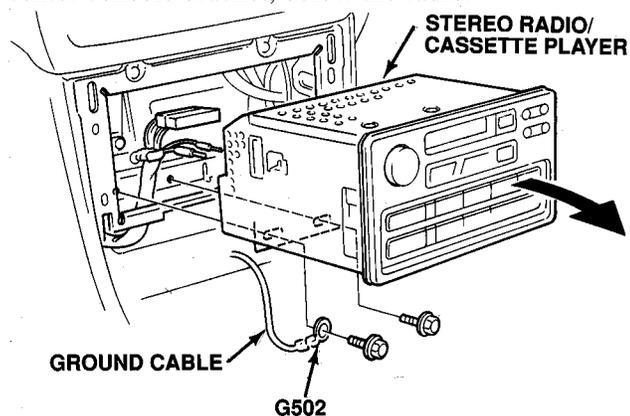
Security system sounds for no reason: If the alarm on a '91 Legend seemingly sounds for no reason, check for a poor ground at G502. G502 is located on the center console bracket, below the radio.
