TL-Series Trailing Arm Torque Specs

ACURA ServiceNews

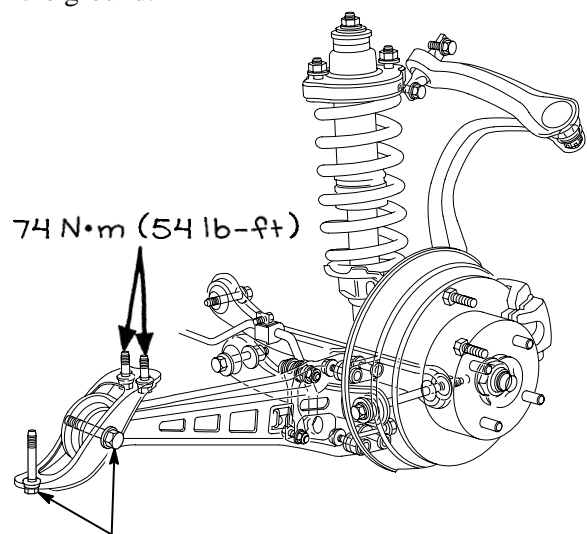
The torque specification for the trailing arm bracket bolts on the TL-series cars has been changed. Change the spec to 74 N·m (54 lb-ft) on pages 18-26 and 18-31 of your '95-96 2.5TL S/M. (If you torqued these bolts to the original spec, you might hear a sharp "crack" from the rear suspension when driving over potholes or speed bumps.) As with other suspension fasteners, torque these bolts with the car on the ground.

FLANGE BOLT
12 x 1.25 mm 74 N·m (54 lb-ft)
~~64 N·m (6.5 kgf·m, 47 lb-ft)~~

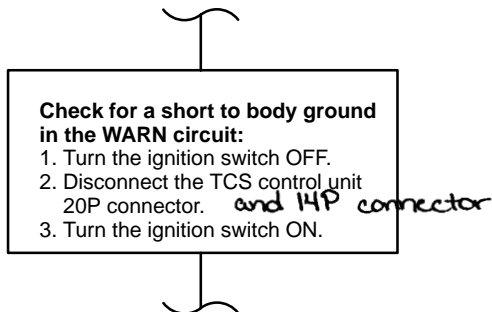
The TCS indicator light troubleshooting on page 19-88 of the '96 3.2TL S/M has a glitch in it. Make the following correction to all of your copies of the S/M.

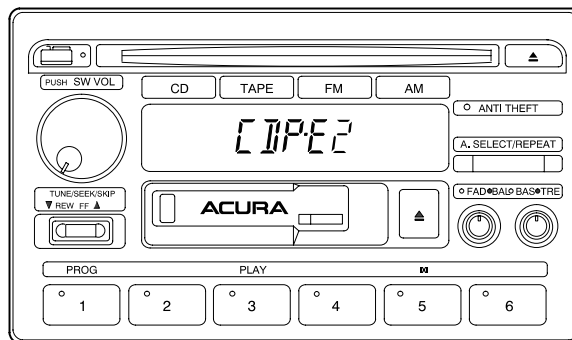
A TL-series CD player that displays error code 2 ("CDPE2") *one time* is nothing to be concerned about; don't replace the audio unit. Error code 2 indicates a microprocessor error. The code is displayed for 10 seconds, then the player ejects the disc. This code is usually caused by external electrical noise (interference) such as an electrical voltage spike, and it rarely recurs.

The TL-series CD players can display two other error codes, "CDPE0" and "CDPE1." Code 0 indicates a data read or search error, and code 1 indicates a mechanical error. Both codes are usually caused by a problem with a particular disc, so try a known-good disc before you condemn the audio unit. For more information, refer to the soon-to-be-released S/B 95-025, *CD Player Error Codes*.
