YEAR
1991

MODEL
LEGEND

BULLETIN NO.
91-011

Ashtray Won't Stay Closed

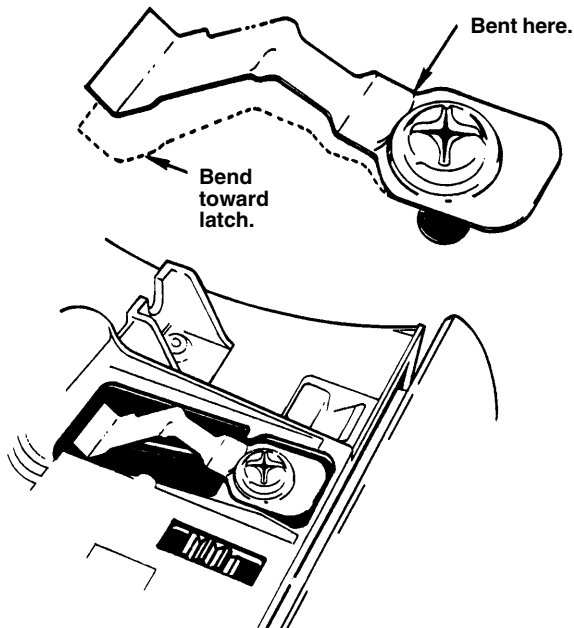
The ashtray won't stay in when it's pushed closed.

Pulling the ashtray out, instead of pushing it in and letting it come out by itself, deforms the ashtray latch spring.

1. Remove the center console panel as described in the Body section of the service manual.
2. Remove the four screws that secure the ashtray to the console panel.
3. Turn the ashtray over, then remove the Phillips screw and the latch spring.

4. Straighten the spring (it usually bends near the screw) so that it applies more pressure to the latch.

5. Reinstall the spring. Hold the ashtray upright and level, then check its operation. The spring tension is OK if the ashtray stays in. Remove and re-bend the spring if necessary.
6. Reinstall the ashtray and the center console cover.
