Legend Shift Cable Recall Bolts

ACURA ServiceNews

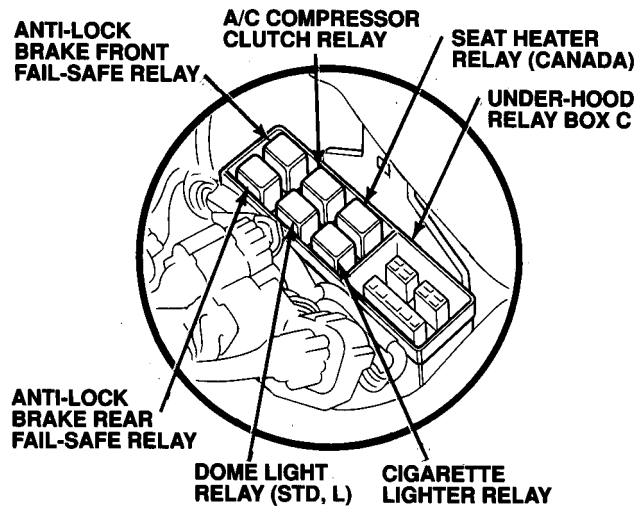
Legend Relay Box "C" Orientation

The illustration of the under-hood relay box C in the '91 Legend Sedan S/M is turned 180°. The relays in the Sedan are on the fender-side of the box, just as they are on a '91 Coupe. To avoid confusion, don't worry about how the relay box is positioned in the car. Just pay attention to how the relays are positioned relative to the box and one another.

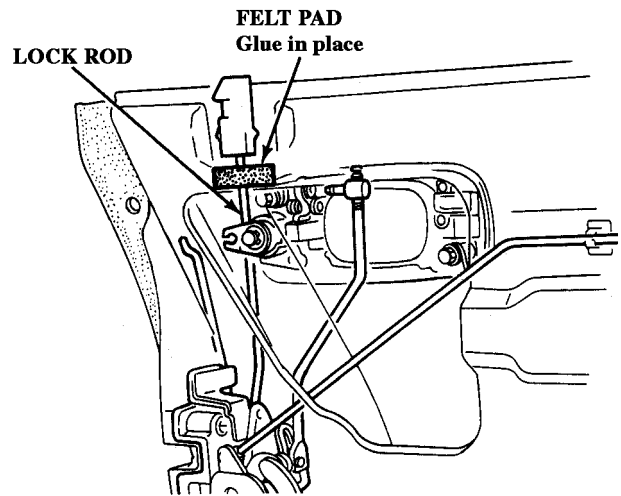
Squelch Vigor Door Rattle

Got a Vigor door that rattles when you shut the door or drive the car? Remove the door panel and check the felt pad that goes in front of the lock knob rod, just below the knob. Chances are you'll find it out of position (maybe even laying in the bottom of the door). Glue it back into position as shown.

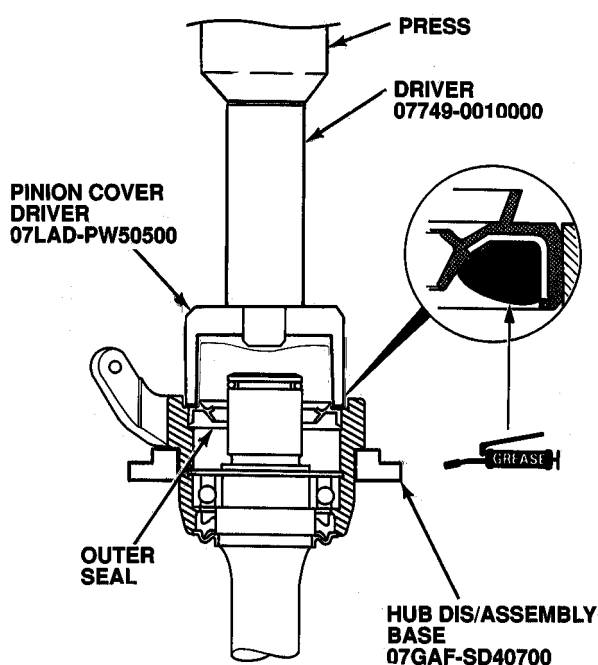
Dual-Purpose Vigor/NSX Tool

Do you want to know another use for the new Pinion Cover Driver, T/N 07LAD-PW50500, that's used on Vigor differentials? It can also be used to install the outer seal into the intermediate shaft bearing support on an NSX. Use a press and the combination of special tools shown below, and make a reference to this article under step 6 on page 16-17 of your NSX S/M.
