## Legend Shift Cable Recall Bolts

## ACURA ServiceNews

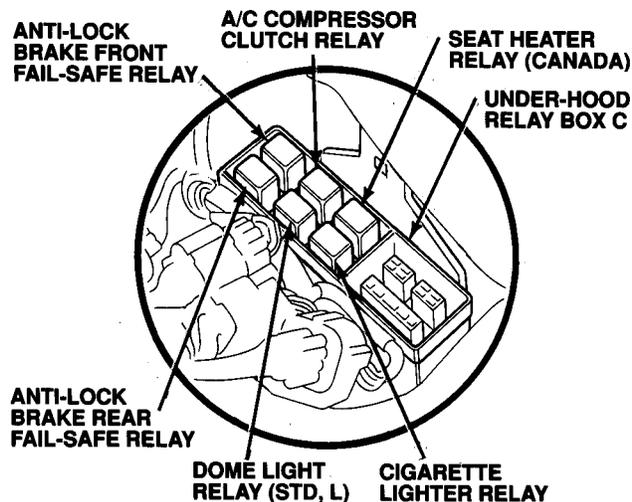
## Legend Relay Box "C" Orientation

The illustration of the under-hood relay box C in the '91 Legend Sedan S/M is turned 180°. The relays in the Sedan are on the fender-side of the box, just as they are on a '91 Coupe. To avoid confusion, don't worry about how the relay box is positioned in the car. Just pay attention to how the relays are positioned relative to the box and one another.

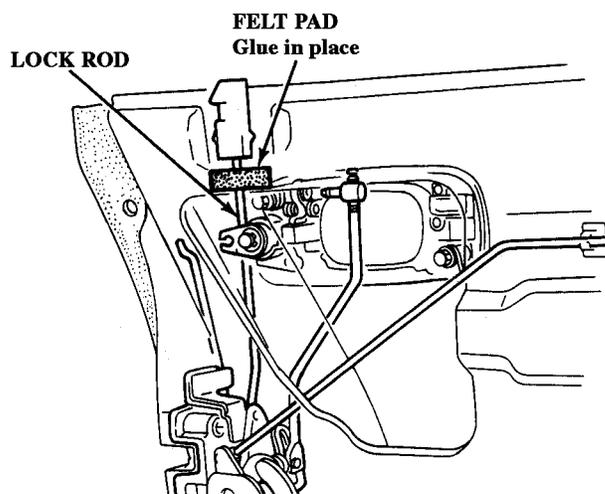
## Squelch Vigor Door Rattle

Got a Vigor door that rattles when you shut the door or drive the car? Remove the door panel and check the felt pad that goes in front of the lock knob rod, just below the knob. Chances are you'll find it out of position (maybe even laying in the bottom of the door). Glue it back into position as shown.

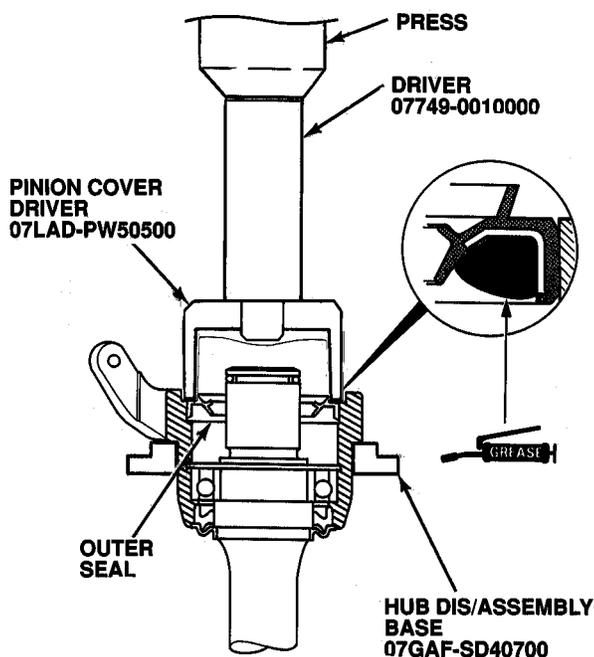
## Dual-Purpose Vigor/NSX Tool

Do you want to know another use for the new Pinion Cover Driver, T/N 07LAD-PW50500, that's used on Vigor differentials? It can also be used to install the outer seal into the intermediate shaft bearing support on an NSX. Use a press and the combination of special tools shown below, and make a reference to this article under step 6 on page 16-17 of your NSX S/M.
