Memory Steering Column/Seat Tips

ACURA ServiceNews

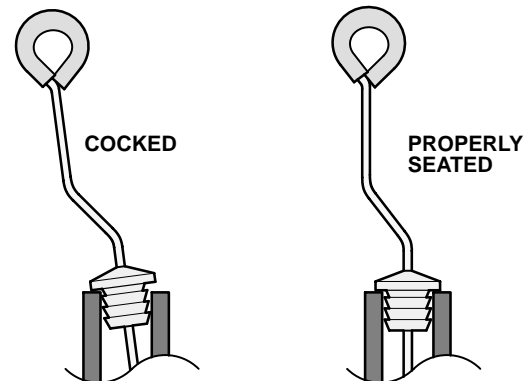
If the A/T dipstick isn't seated squarely in a '94 Integra, it can cock enough to contact the reverse shift fork and gear. At the very least, this causes a disconcerting noise; at the worst, it may prevent the trans from engaging reverse. The bend in the handle makes it easy to cock the dipstick, so make sure the rubber plug is seated all the way around.

If you find a dipstick that's had only a minor run-in with reverse gear (it's a little chewed up but all there), replace the dipstick, and flush the trans. If the dipstick is seriously deformed or part of it is missing, the trans will need to be replaced with a remanufactured unit.

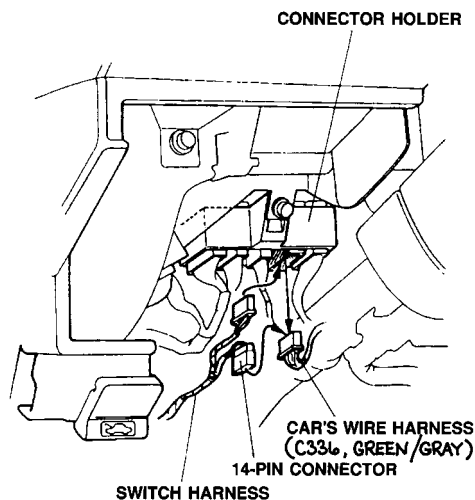
'94 Legend fog light installation: Some people have a hard time finding connector C336 (14-P) when installing fog lights on a '94 Legend. The '94 Sedan installation instructions (step 13) say it's a green connector, while the '94 Coupe instructions (step 11) say it's a gray connector. They're both half right – one half of C336 is green and the other half is gray.
