YEAR
1991

MODEL
LEGEND

BULLETIN NO.
91-034

Power Steering Pump Noise

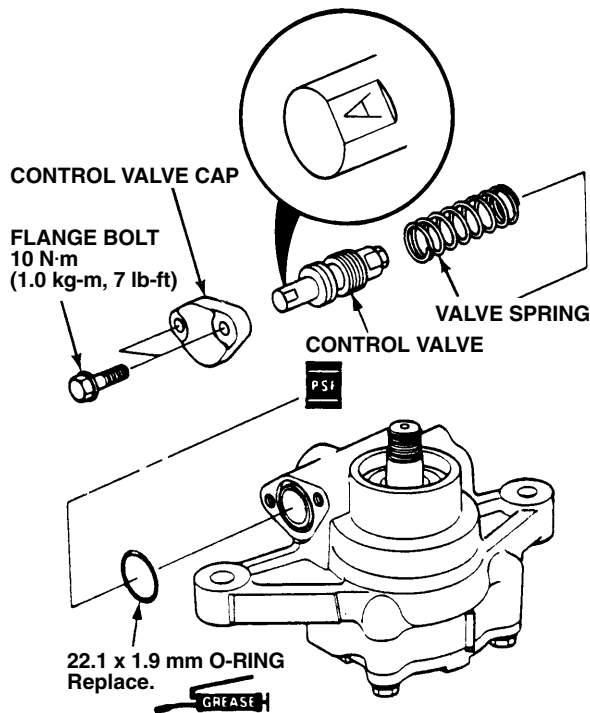
Complaints of a hydraulic "swooshing" sound coming from the power steering pump, while turning when the power steering fluid is cold.

1. Remove the power steering pump as described in the service manual.
2. Remove the control valve cap and remove the control valve. Verify the control valve size by looking for the identification letter (A or B) stamped on the valve as shown.

Replace the power steering pump control valve.

3. Replace the original control valve with a new control valve with the same identification letter. Refer to PARTS INFORMATION.
4. Replace the O-ring and install the new control valve. Reinstall the control valve cap and torque the bolts.
5. Reinstall the power steering pump as described in the service manual.

Control Valve A: P/N 56170-PY3-020
 Control Valve B: P/N 56180-PY3-020
 O-ring 22.1 x 1.9: P/N 91346-PY3-000
