New Way to Adjust A/T Throttle Cable

Spilled Drinks Stick Integra Cup Holder

ACURA ServiceNews

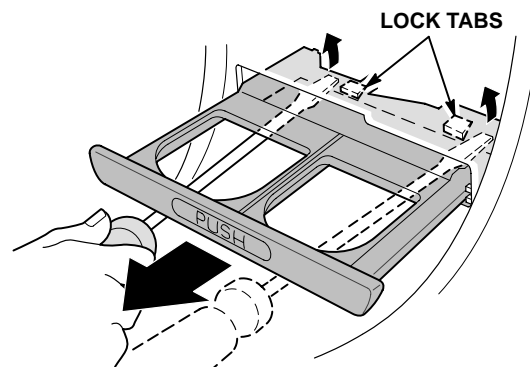
The sticky residue from sloshed drinks may cause the beverage (cup) holder to stick on a '94-95 Integra. Luckily, however, you don't have to replace the cup holder; just take it apart and clean it.

1. Pull the cup holder open. Using a long, thin, flat tip screwdriver, carefully release both lock tabs (one on each side), and remove the cup holder.

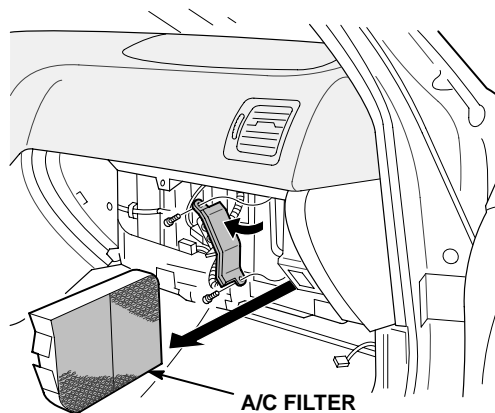
If the charcoal-impregnated filter located between the blower and evaporator on '92-'94 Legends* gets used up, evaporator odor may develop. Replace this filter (P/N 79370-SP0-H01) every 15,000 miles or 12 months.

While this filter helps prevent odor, it won't eliminate the odor if the evaporator becomes contaminated. If the evaporator appears (smells) contaminated, disassemble and clean it as described in the June '92 issue of S/N before installing a new filter.
