New Way to Adjust A/T Throttle Cable

Spilled Drinks Stick Integra Cup Holder

Old A/C Filters Promote Odor

ACURA ServiceNews

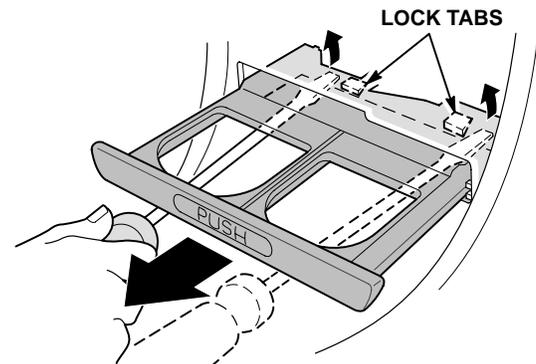
The sticky residue from sloshed drinks may cause the beverage (cup) holder to stick on a '94-95 Integra. Luckily, however, you don't have to replace the cup holder; just take it apart and clean it.

1. Pull the cup holder open. Using a long, thin, flat tip screwdriver, carefully release both lock tabs (one on each side), and remove the cup holder.

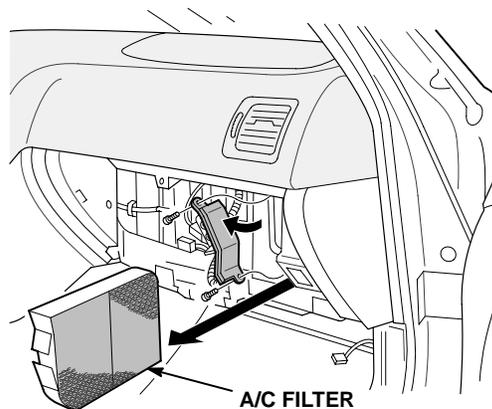
If the charcoal-impregnated filter located between the blower and evaporator on '92-'94 Legends* gets used up, evaporator odor may develop. Replace this filter (P/N 79370-SP0-H01) every 15,000 miles or 12 months.

While this filter helps prevent odor, it won't eliminate the odor if the evaporator becomes contaminated. If the evaporator appears (smells) contaminated, disassemble and clean it as described in the June '92 issue of S/N before installing a new filter.
