Minimize Integra Moonroof Chatter

ACURA ServiceNews

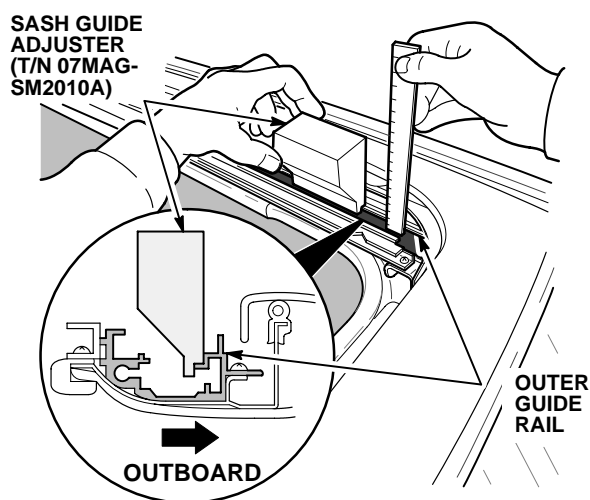
A chattering noise while opening or closing the moonroof on a '94-96 Integra can be minimized by reducing the clearance between the guide rails and the sliders.

1. Open the sunshade, then remove the moonroof glass (three hex-head bolts on each side).
2. Clean the inside of both moonroof guide rails with a shop towel dipped in cleaning solvent. Be sure you remove all traces of dirt, sand, salt, etc.
3. With the Sash Guide Adjuster (T/N 07MAG-SM2010A) and a rubber mallet, tap lightly along the outer guide rails to reduce clearance by 0.5 mm (0.20 inch). For an accurate measurement, place a ruler inside the rail and watch it while you tap.

4. Lube the guide rails with Super Hi-Temp Urea Grease, P/N 08798-9002.
5. Reinstall the glass, and test the operation of the moonroof.
