YEAR  
1994

MODEL  
LEGEND

BULLETIN NO.  
95-001

## DPMS Steering Column Noise

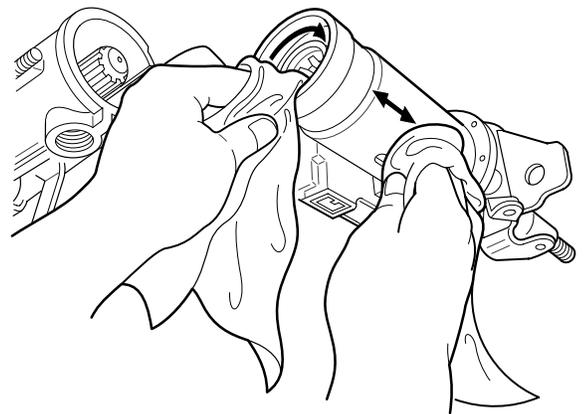
Insufficient lubricant on the telescoping section of the driver's position memory system (DPMS) steering column.

16. With a shop towel, clean the inside spline portion of the steering column shaft, and the outside sliding surface of the telescoping section.
