Do You *Really* Need to Replace the Trans?

NOTE: This article applies to '99 3.2TLs, '97-99 3.0CLs, and '98-99 2.3CLs.

ACURA ServiceNews

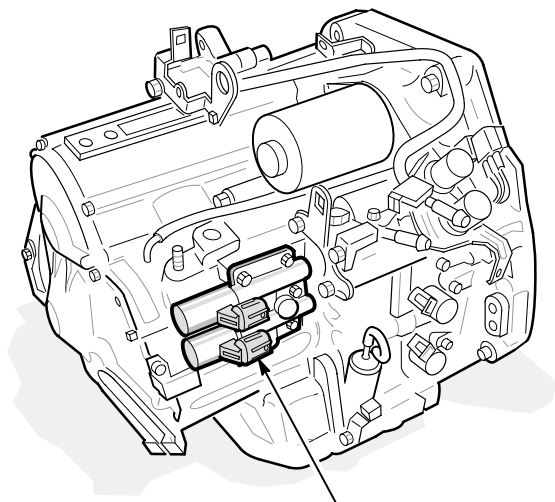
A/T CLUTCH PRESSURE CONTROL SOLENOID A/B ASSEMBLY

1. Inspect the A/T clutch pressure control solenoid valve A/B assembly. Look for valve damage or leaks, and make sure the wires and connectors are OK.

NO – Replace the valve, then go to step 2.

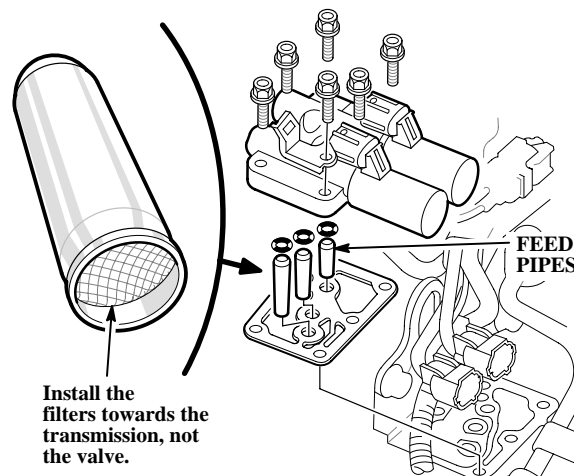
- On L4s, there are three same-length pipes, each with a filter inside.
- On V6s, note the length of each pipe, the port you removed it from, and the pipe without a filter. (The filters on early '97 3.0CLs are in the valve itself.)

5. Check the feed pipe filters for contamination.

7. Make sure the feed pipe filters are clean, then reinstall each one on either end of the pipe you removed it from.
8. Reinstall the pipes, filter side toward the trans. V6 pipes are port-specific; L4 pipes are not.
9. Install a new or a known-good clutch pressure control solenoid valve A/B assembly.
10. Refill the trans with Genuine Honda ATF, and test-drive the car.

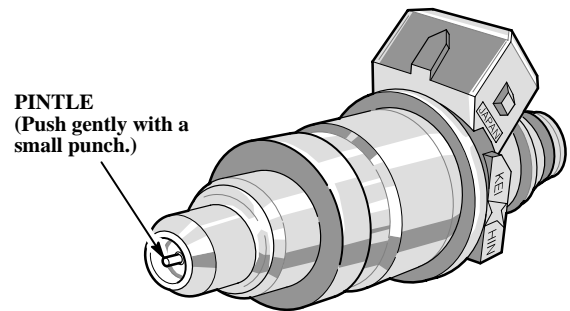
Replacement fuel injectors come with rust inhibitor inside them. If injectors sit for a long time on the shelf, the rust inhibitor can cause them to "gum up" and stick.

So before you install *any* new injector, take a small, flat-tip punch and gently push down on the injector's pintle. Don't push too hard, or you'll damage the injector. As long as you can push the pintle, the injector will work fine when you install it.
