Do You *Really* Need to Replace the Trans?

NOTE: This article applies to '99 3.2TLs, '97-99 3.0CLs, and '98-99 2.3CLs.

ACURA ServiceNews

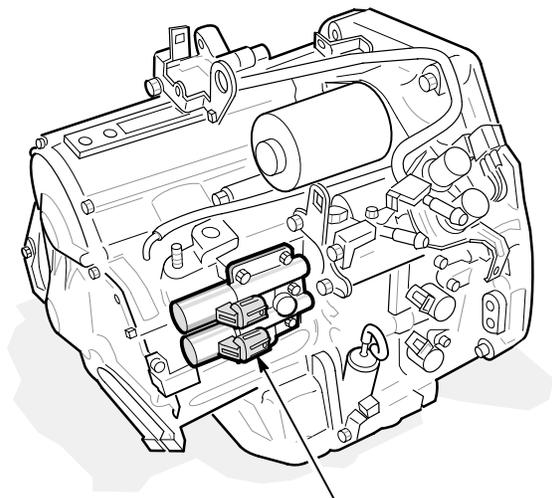
A/T CLUTCH PRESSURE CONTROL SOLENOID A/B ASSEMBLY

1. Inspect the A/T clutch pressure control solenoid valve A/B assembly. Look for valve damage or leaks, and make sure the wires and connectors are OK.

NO – Replace the valve, then go to step 2.

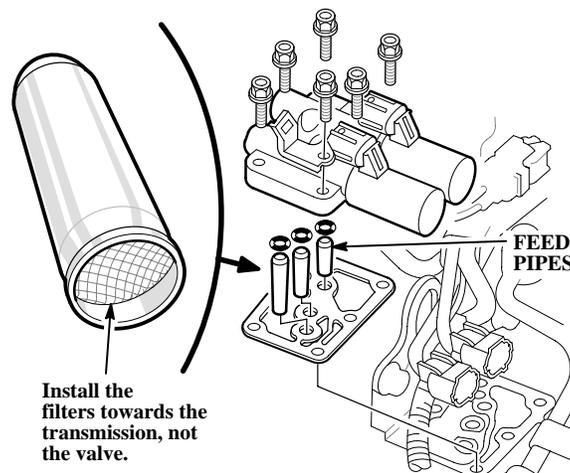
- On L4s, there are three same-length pipes, each with a filter inside.
- On V6s, note the length of each pipe, the port you removed it from, and the pipe without a filter. (The filters on early '97 3.0CLs are in the valve itself.)

5. Check the feed pipe filters for contamination.

NO – Go to step 7.
7. Make sure the feed pipe filters are clean, then reinstall each one on either end of the pipe you removed it from.
8. Reinstall the pipes, filter side toward the trans. V6 pipes are port-specific; L4 pipes are not.
9. Install a new or a known-good clutch pressure control solenoid valve A/B assembly.
10. Refill the trans with Genuine Honda ATF, and test-drive the car.

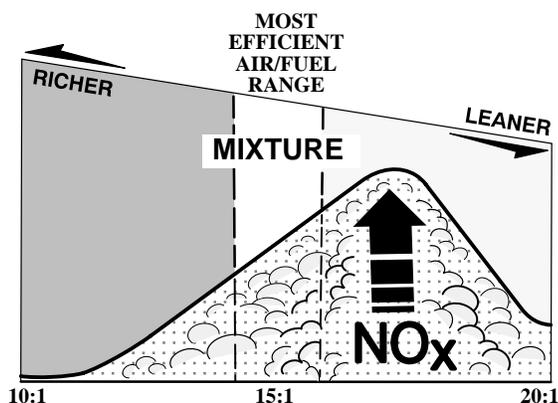
NO_x levels are mostly affected by combustion temperature, but they also tend to vary with mixture levels.

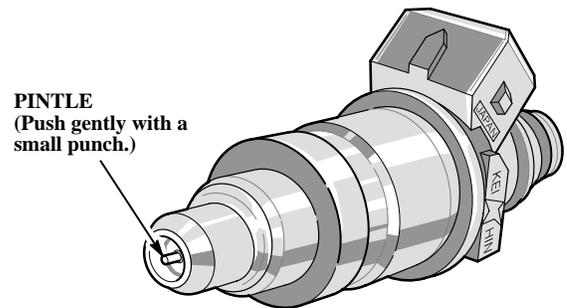
Replacement fuel injectors come with rust inhibitor inside them. If injectors sit for a long time on the shelf, the rust inhibitor can cause them to "gum up" and stick.

So before you install *any* new injector, take a small, flat-tip punch and gently push down on the injector's pintle. Don't push too hard, or you'll damage the injector. As long as you can push the pintle, the injector will work fine when you install it.
