2.5TL SRS Unit Removal Changes

VTEC Pressure Switch Torque Spec

ACURA ServiceNews

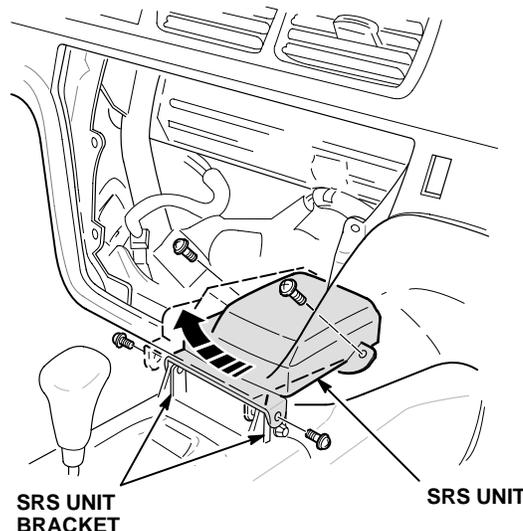
Due to a mid-production change in dashboard brackets, the SRS unit on a '96 2.5TL can't be removed as easily as the S/M describes. At first glance, it now looks like the dashboard must be removed, but it's not that bad.

- Remove the four Torx bolts from the SRS unit, then shift the unit's rear mounting tabs up and over the SRS unit bracket, toward the left.

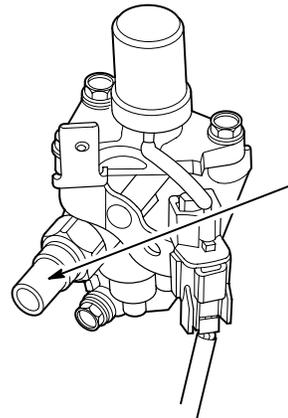
After all these years, we finally realized that neither the Integra or NSX S/Ms list a torque specification for the VTEC pressure switch. The spec is 22 NVm (2.2 kg-m, 16 lb-ft), and a good place to note the spec is on the VTEC Pressure Switch (DTC 22) Troubleshooting Flowchart page in section 6.

VTEC PRESSURE SWITCH
22 N·m
(2.2 kg-m, 16 lb-ft)
