Legend Lock Knob Breakage

ACURA ServiceNews

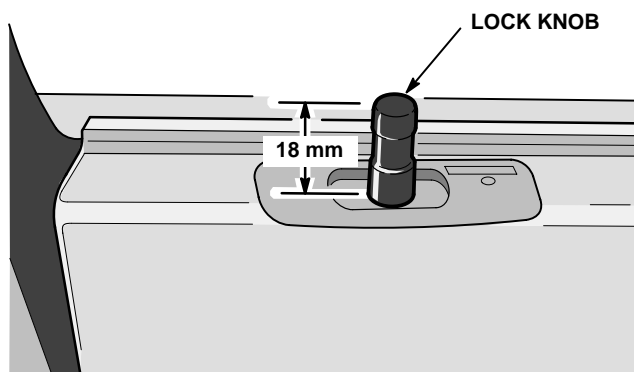
Misadjusted '91-93 Legend Sedan door lock knobs (ones that stick up too high) are more prone to breakage. They get smacked by elbows, caught in shirt sleeves, and snagged by car wash towels.

If you're replacing a broken lock knob, tighten the new one until it's at the height spec listed in the S/M: 18 mm exposed when the door is locked. (And while you have your ruler out, you might as well check the other three.)

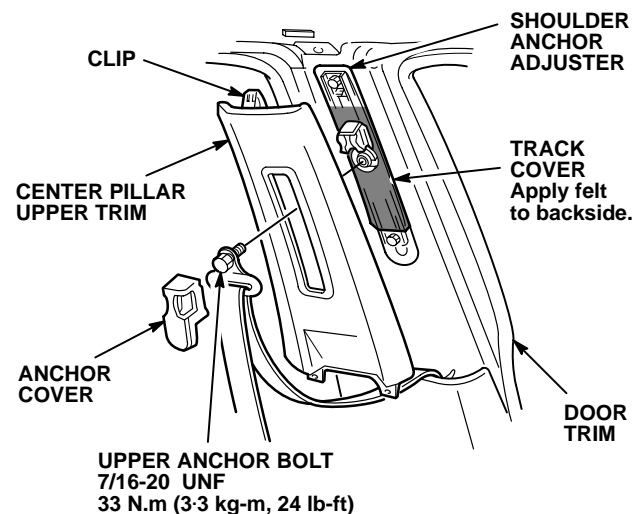
The front shoulder belt anchor adjuster track cover may contact the center pillar upper trim and rattle on some '93 Legend Sedans. If you have a car with this symptom, insert some felt between the anchor track and the track cover, as described below. The felt eliminates the clearance between the track cover and pillar trim, and it provides a cushion between the track and cover.

1. Remove the front and rear door opening trim from the center pillar area.
2. Remove the anchor cover and the upper anchor bolt.
3. Pull the lower section of the center pillar upper trim away from the body to gain access to the shoulder belt anchor adjuster. (You don't have to completely remove the trim.)
4. Cut a 6 mm wide strip of felt (P/N 06993-SA5-000), and apply it to the back of the track cover, where it contacts the track.

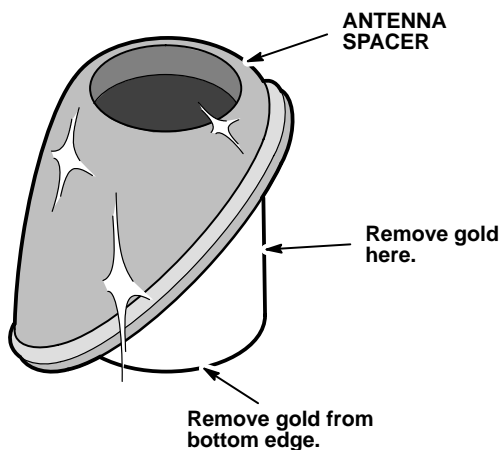
If a Legend or Vigor comes in with a radio reception problem, check the car for a gold emblem kit. What do gold emblems have to do with radio reception? Nothing, but that gold antenna spacer might be the culprit.

Remove the gold antenna nut and the antenna spacer, and inspect the part of the spacer that goes inside the fender. If that area is gold plated (it's not supposed to be), the spacer may be acting as a conductor to ground instead of as an insulator.

Using a utility knife or file, remove the gold plating from the lower part of the spacer and its bottom edge.

Loosely reinstall the antenna spacer and antenna nut. Loosen the antenna motor mounting nuts, then retorque the antenna nut to 20 lb-in. (Loosening the motor allows the antenna collar to make a good ground when you torque the antenna nut.) Retighten the motor mounting nuts.
