YEAR
1991 - 93

BULLETIN NO.
95-020

A/C Blows Warm Air Intermittently

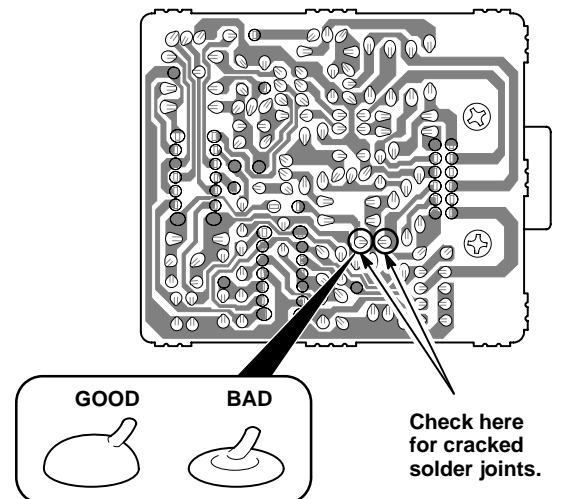
PRINTED CIRCUIT BOARD

A cracked solder joint on the fan control unit's printed circuit board causes the air conditioner compressor and fans to intermittently turn off.

4. Release the four tabs on the fan control unit housing with a small screwdriver, then remove the printed circuit board.
5. Inspect the two solder joints indicated with a magnifying glass to see if they are cracked.

- If either of the solder joints are cracked, replace the fan control unit (see PARTS INFORMATION).
- If the solder joints are not cracked, continue troubleshooting the air conditioner system to locate the cause of the problem.
