**ACC** Cassette Problems: Is the Player at Fault?

### ACURA ServiceNews

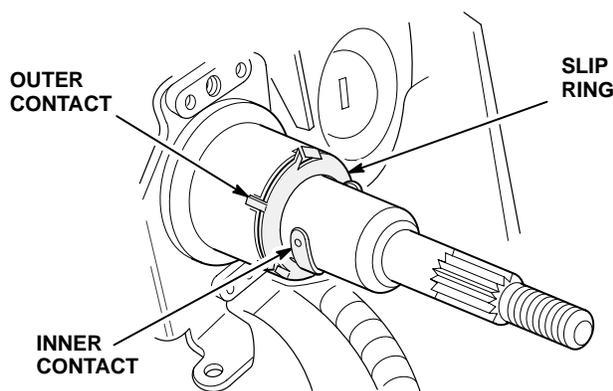
Two things make the steering-wheel-mounted remote audio controls on a Legend more sensitive to variations in electrical resistance: adding a cellular phone control unit and the driving position memory system (DPMS). When the resistance is incorrect, the radio may change stations when you press one of the volume controls while turning the steering wheel. Consequently, whenever you install an Acura cellular phone in a '94-95 Legend, go ahead and install a slip ring assembly, P/N 35257-SP0-315, on the steering column to prevent a potential comeback. Refer to S/B 91-045, *Erratic Remote Audio Control Operation*.
