TL Meter Panel & Steering Column Cover Removal

ACURA ServiceNews

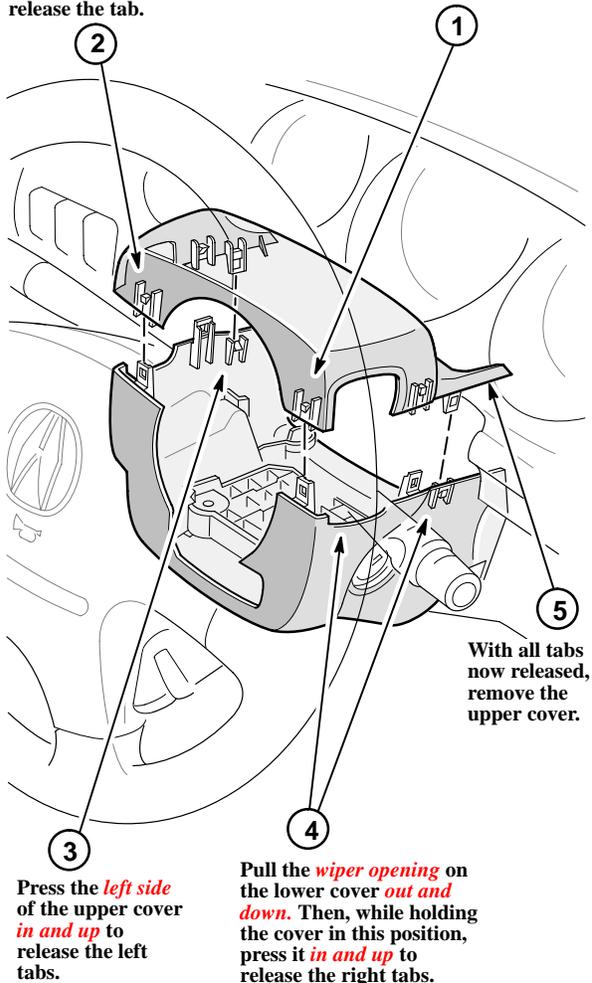
Turn the steering wheel 45° to the left. Then press the **left corner in and up** to release the tab.

Unlock the steering wheel, and turn it 45° to the right. Then press the **right corner in and up** to release the tab.

1. Turn the heater on for a few minutes to warm the dashboard and make the parts more flexible.
2. Tilt the steering column all the way down.
3. Remove the steering column upper cover. (This prevents the upper cover from getting scratched by the meter panel, and it'll also help you avoid damage whenever you need to remove the upper cover.)

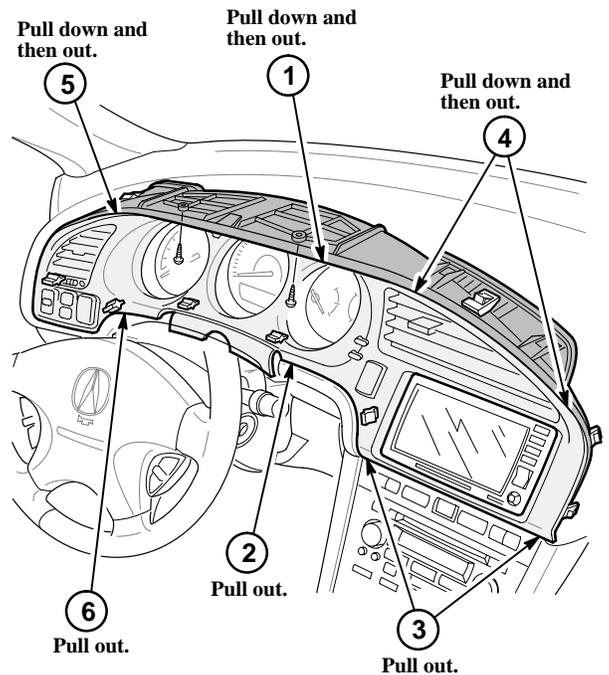
4. Remove the two meter panel screws above the gauge assembly.
5. Detach the meter panel's metal clips in this sequence:

6. Disconnect the connectors on the left and right sides of the panel, then remove the panel.
7. Make sure none of the mounting tabs are broken and all of the metal clips are in place.

NOTE: To avoid breaking the panel's left side tab, don't hit or force the left vent or the air flow dial below the vent.

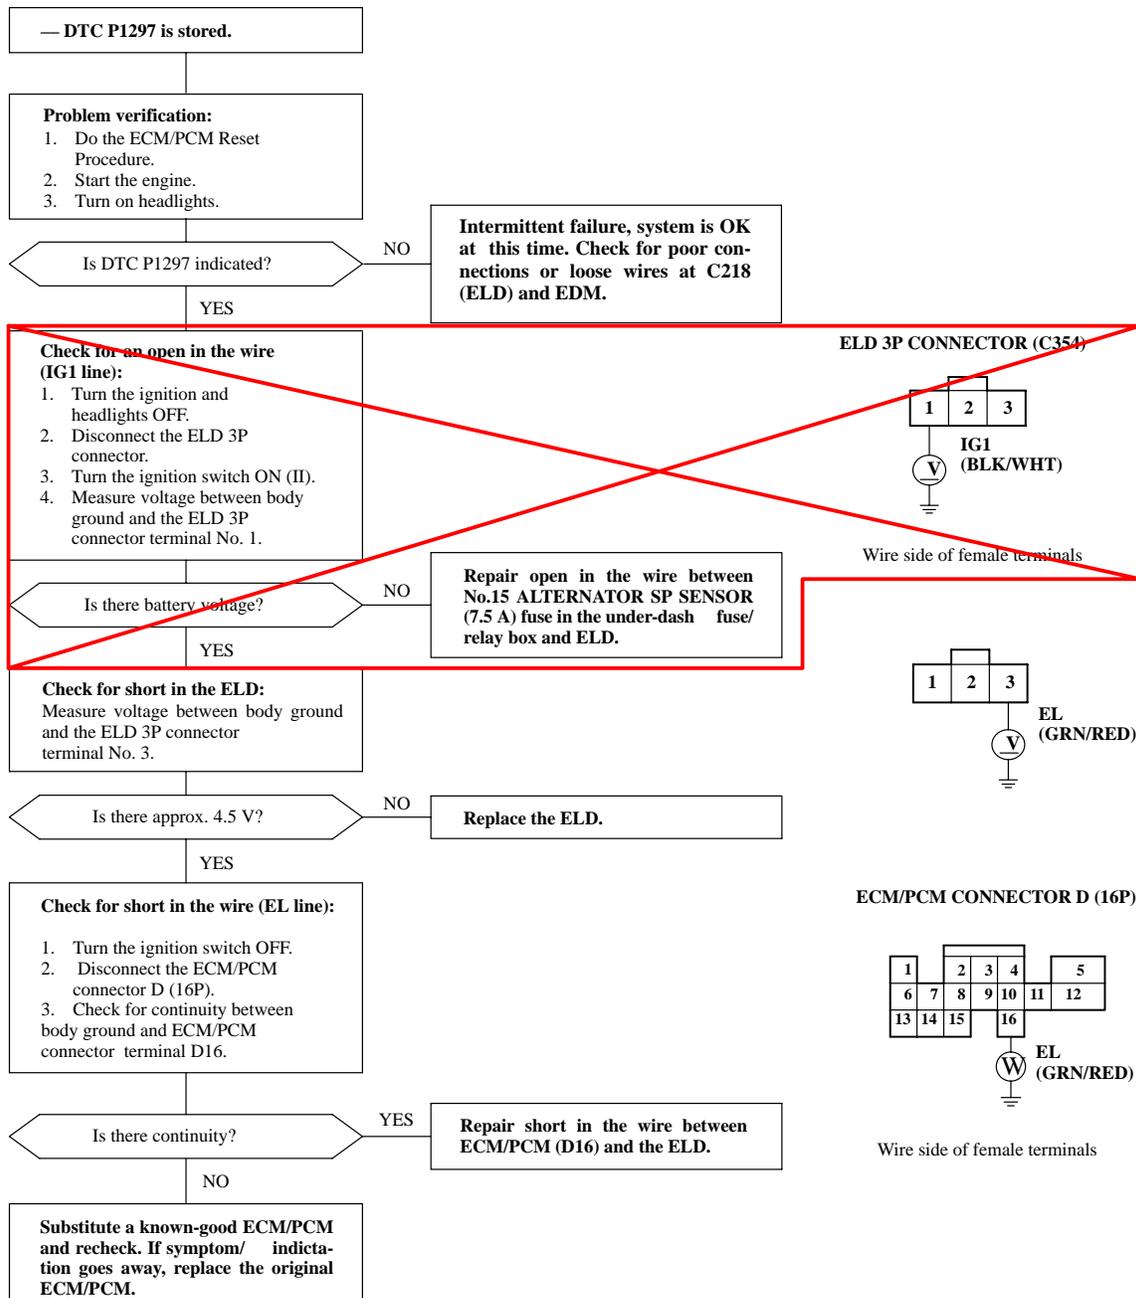
Page 11-88, DTC P1297:

P1297 The scan tool indicates Diagnostic Trouble Code (DTC) P1297: A low voltage problem in the Electrical Load Detector (ELD) circuit.

Delete the info in the middle of the troubleshooting chart.
