What to Expect on the New Integra

93 Legend Idle Speed Adjustment

ACURA ServiceNews

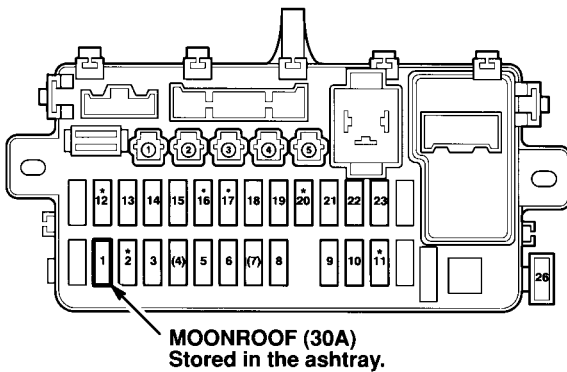
UNDER-DASH FUSE/RELAY BOX

Fuse installation at PDI: To get all systems functioning, remove the following fuses from their storage areas and install them in the proper positions.

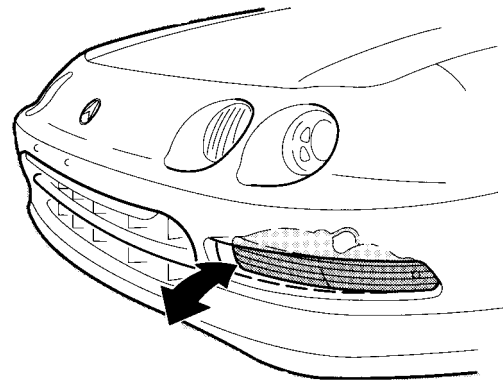
Spring-loaded front turn signals: The combined front turn signal and side marker light assemblies are spring-loaded to survive minor impacts. You can push the lights in about an inch, and they’ll pop back to their original position.

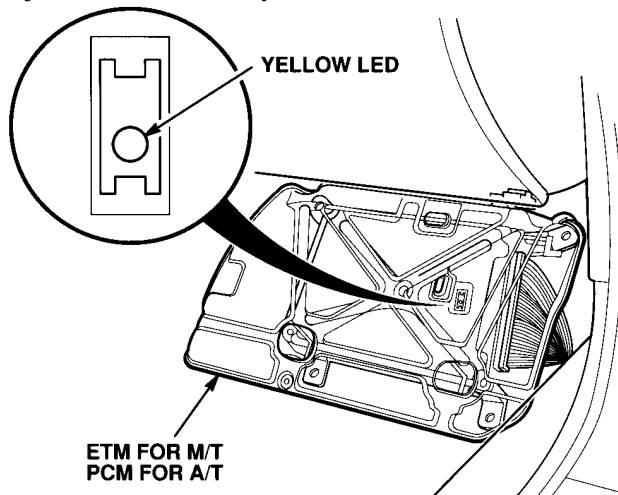
The idle speed adjustment procedure in the 1993 Legend S/M uses the yellow LED on ECM/PCM to check the idle speed. However, the idle speed adjustment procedure in the October 1991 issue of S/N is less time-consuming. (In a nutshell, adjust the idle speed to 500 rpm with the EACV disconnected and the headlights, rear defogger, and blower fan on.)

After setting the idle speed, reconnect the EACV, and clear the ECM/PCM. Jump the service check connector, and start the engine. The yellow LED should be off. If the LED is blinking, turn the adjusting screw 1/4 turn clockwise; if it's on, turn the adjusting screw 1/4 turn counterclockwise. Wait 30 seconds, then check the LED to determine if further adjustment is necessary.
