O₂ Sensors: How They Work & Why They Quit

ACURA ServiceNews

BSN 16929 (9412)

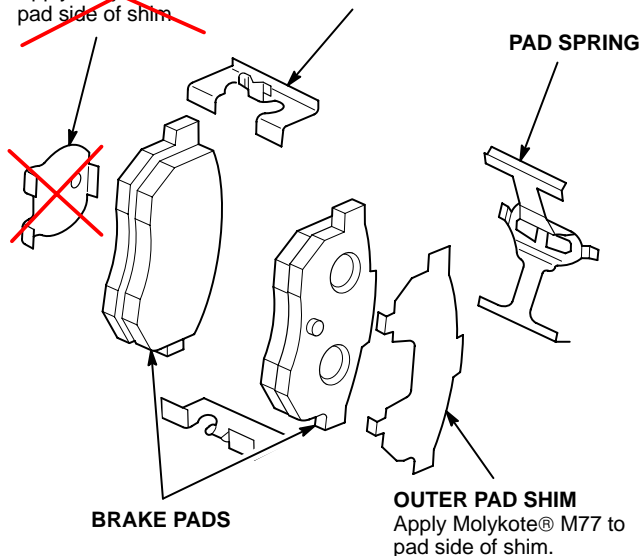
The rear inner brake pad shim shown on page 19-23 of the '94 Integra S/M shouldn't be there. Cross it out; the car doesn't use an inner shim. The '95 Integra S/M has been corrected.

~~INNER PAD SHIM~~
